Technical Appendix 7.4

# Clune Wind Farm

## Fish Habitat Survey

September 2024

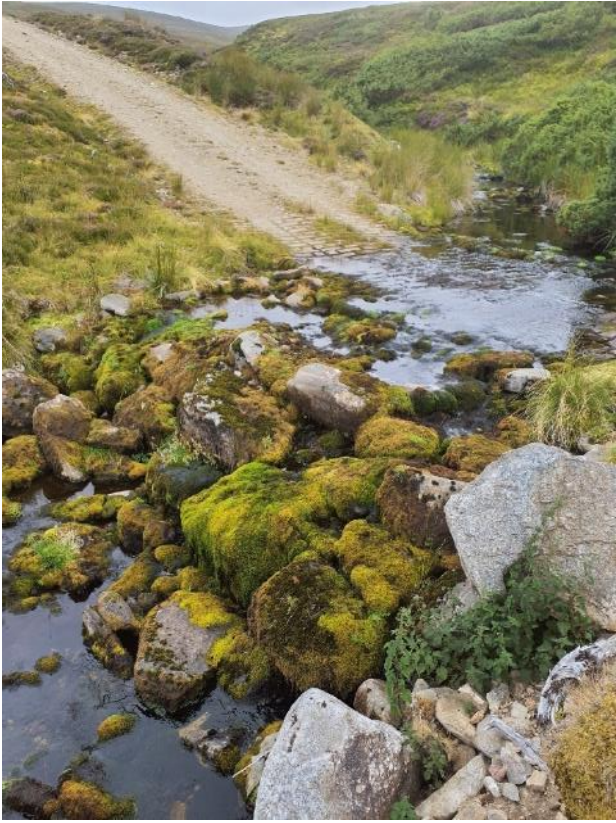
Target Note description	Photo
<p><b>TN1 Photo 1</b>  <b>Grid ref:</b>  <b>NH 77570 22053</b>                      Upper section of Wester Strathnoon Burn looking u/s. Ford with artificial rock dam. Impassable during low flows.</p>

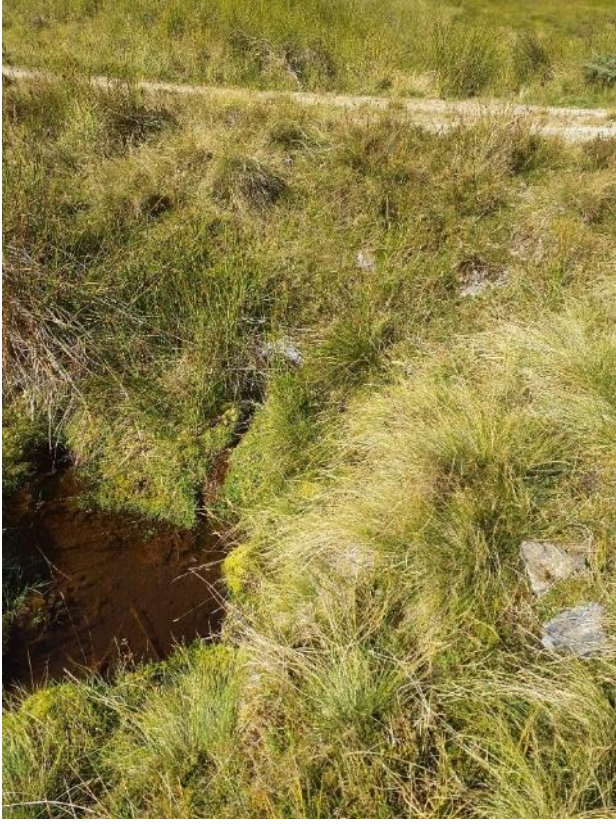
Target Note description	Photo
<p><b>TN6 Photo 6</b>  <b>Grid ref:</b>  <b>NH 78701 21698</b>                      Upper section of <i>Caochan nan Gamhainn</i>. Double pipe culvert. Impassable.</p>

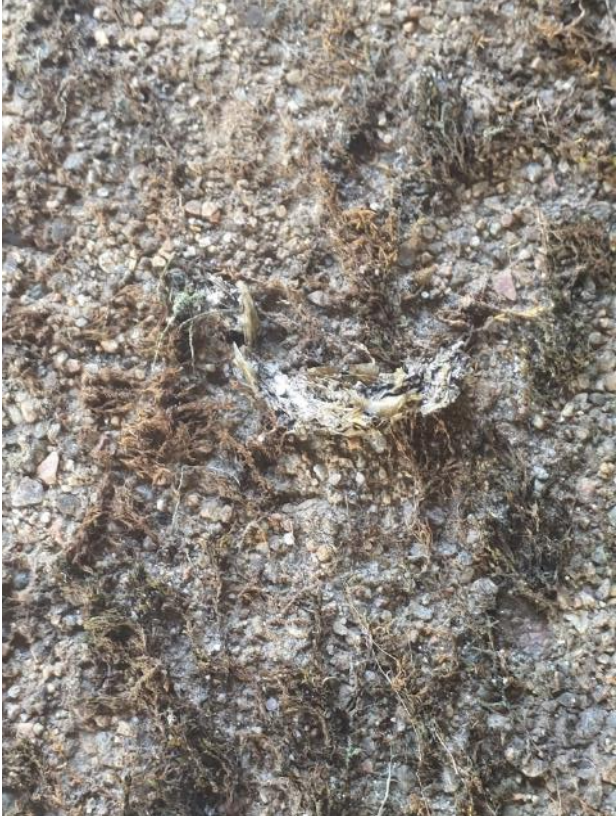
<p><b>TN7 Photo 7</b>  <b>Grid ref:</b>  <b>NH 79416 22276</b>                      Upper section of <i>Allt Lathach</i>. Incidental old otter spraint underneath bridge. Contains fishbones and scales.</p>

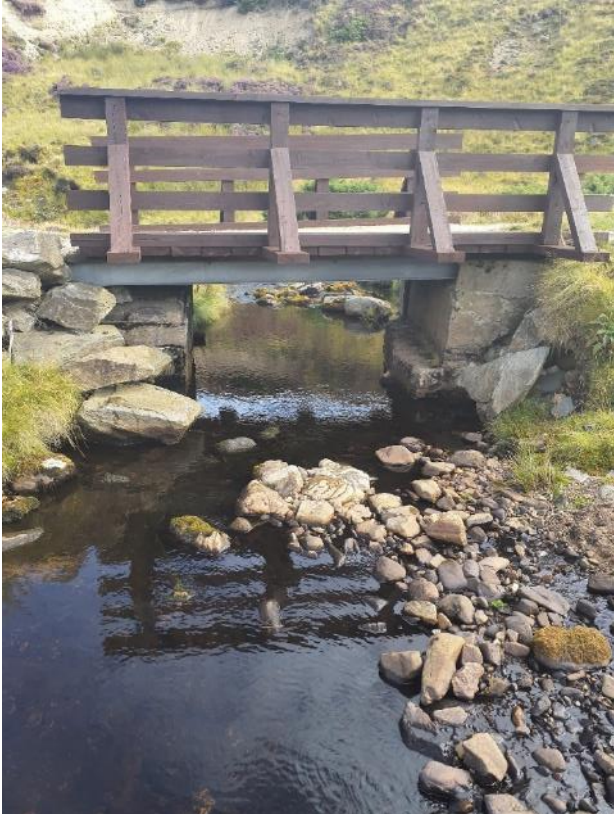
Target Note description	Photo
<p><b>TN8 Photo 8</b>  <b>Grid ref:</b>  <b>NH 79411 22273</b>                      Upper section of <i>Allt Lathach</i> looking d/s. Vehicle bridge with 3m wide channel and 30cm average depth.</p>

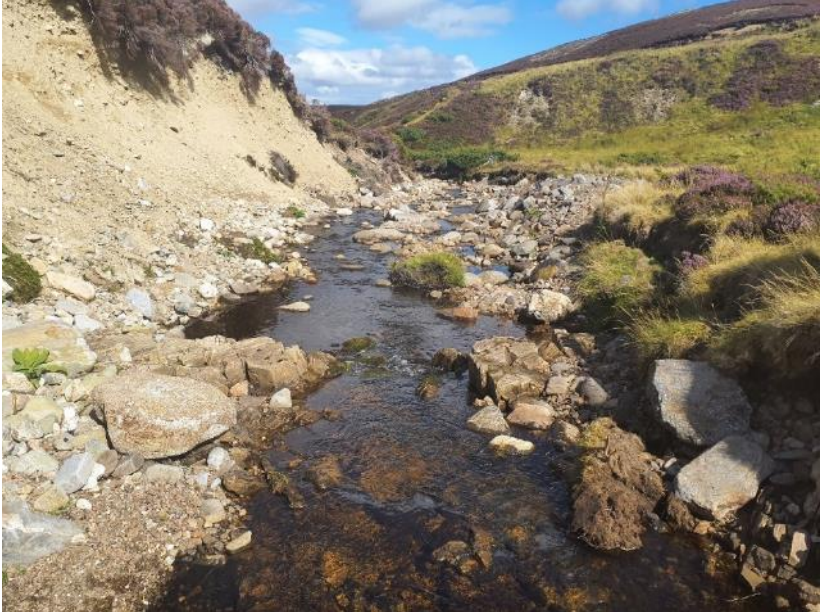
<p><b>TN9 Photo 9</b>  <b>Grid ref:</b>  <b>NH 79366 22346</b>                      Upper section of <i>Allt Lathach</i> looking d/s. 4m wide run. Boulders in channel with bedrock intrusion and eroding adjacent cliff face.</p>

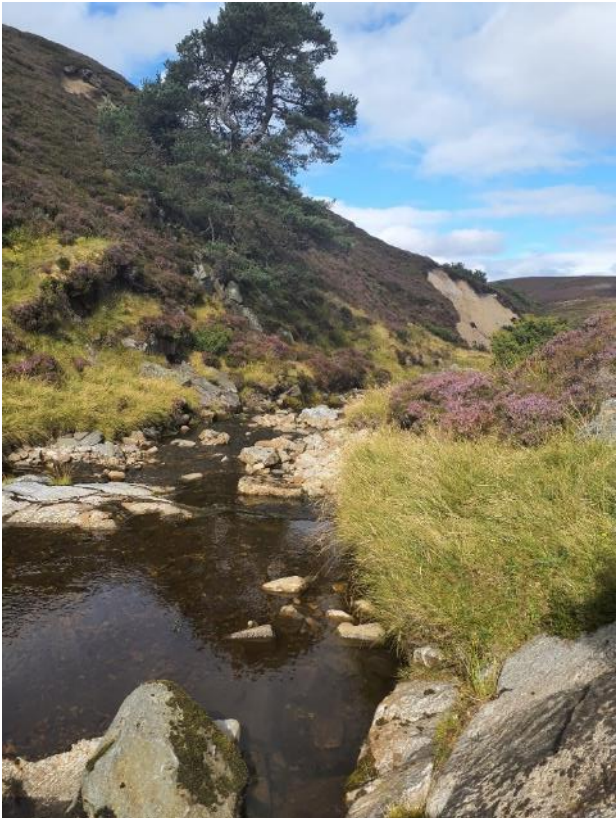
Target Note description	Photo
<p><b>TN10 Photo 10</b>  <b>Grid ref:</b>  <b>NH 79305 22605</b>                      Upper section of <i>Allt Lathach</i> looking d/s. 4m wide channel and 25cm depth. Boulders in channel with bedrock intrusion. Parr observed in watercourse.</p>

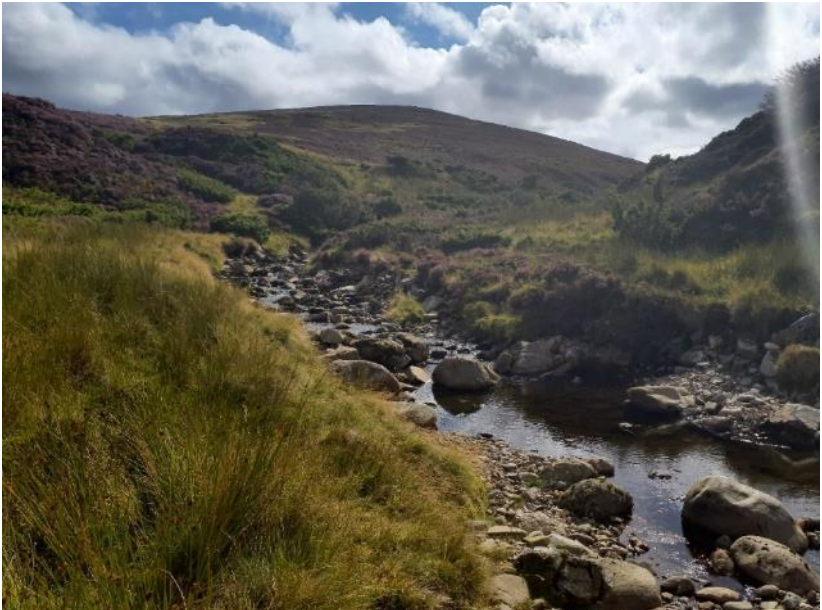
<p><b>TN11 Photo 11</b>  <b>Grid ref:</b>  <b>NH 79157 22897</b>                      Mid-section of <i>Allt Lathach</i> with dry unnamed tributary looking u/s. Main channel contains many boulders. Multiple fish observed.</p>

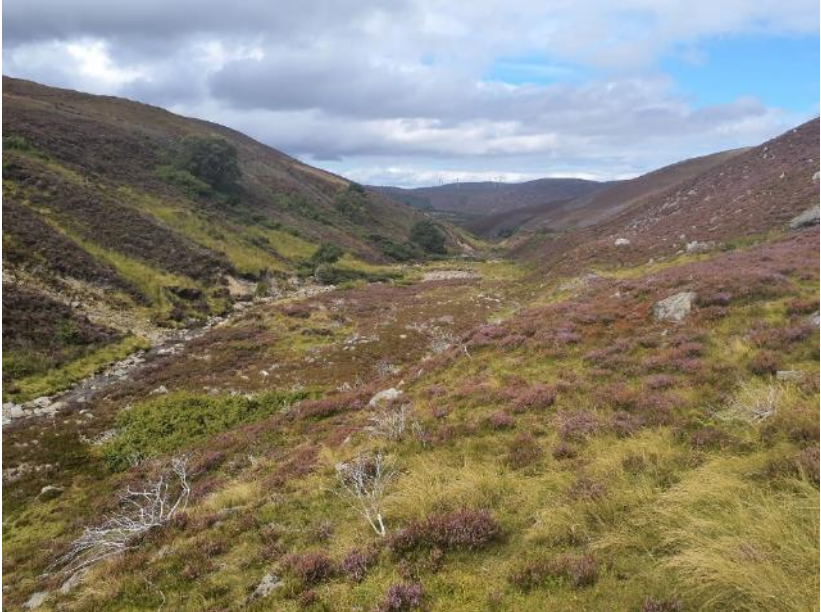
Target Note description	Photo
<p><b>TN12 Photo 12</b>  <b>Grid ref:</b>  <b>NH 78861 23147</b>                      Mid-section of <i>Allt Lathach</i> looking d/s within valley context. Many boulders and rocks in channel.</p>

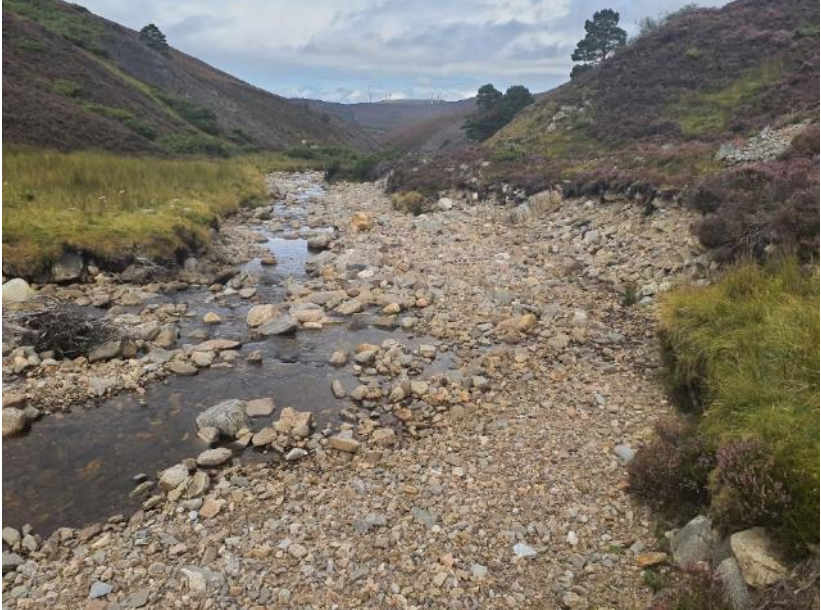
<p><b>TN13 Photo 13</b>  <b>Grid ref:</b>  <b>NH 78582 23495</b>                      Mid-section of <i>Allt Lathach</i> looking d/s. Run with highly active channel, large amount of washed-out sediment and boulders.</p>

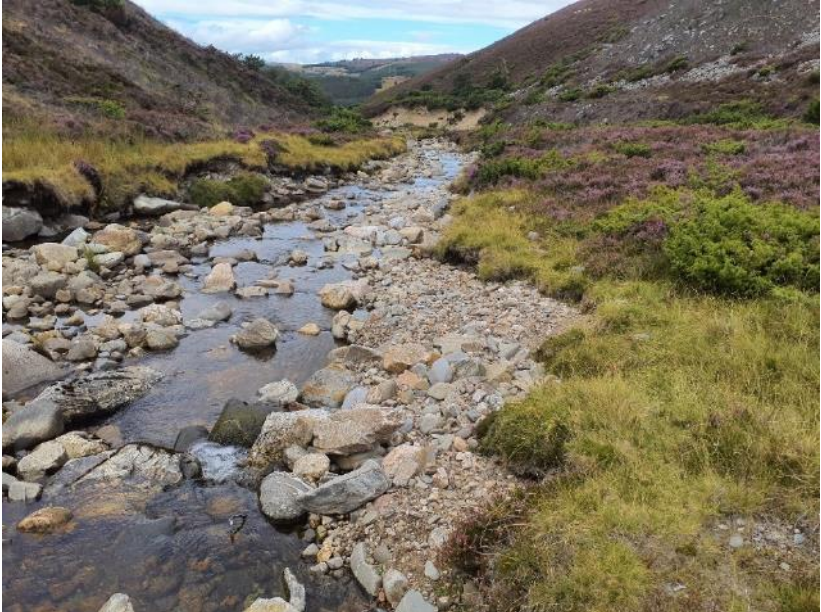
Target Note description	Photo
<p><b>TN14 Photo 14</b>  <b>Grid ref:</b>  <b>NH 78253 23882</b></p> <p>Lower section of <i>Allt Lathach</i> looking d/s.                      5m wide channel with 30cm depth. Bedrock intrusion, exposed boulders, and sediment present. Becoming a medium gradient, still good fish habitat.</p>

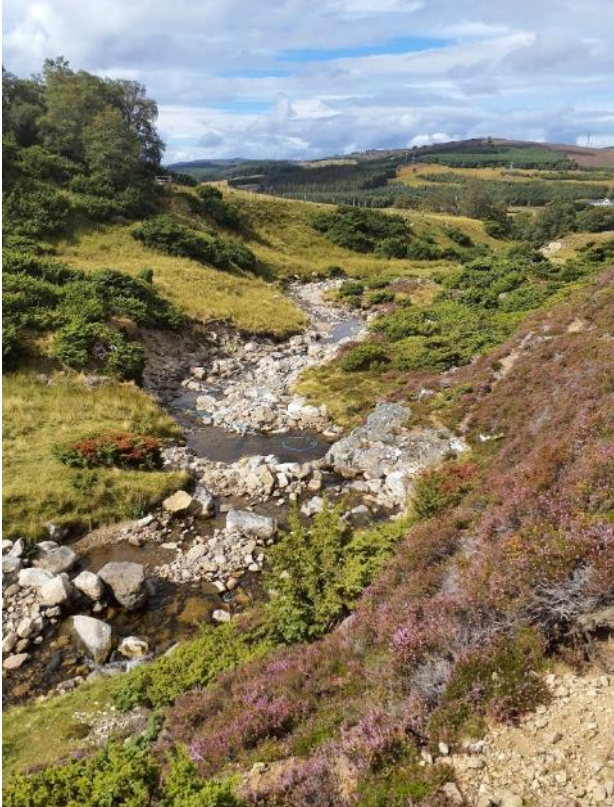
<p><b>TN15 Photo 15</b>  <b>Grid ref:</b>  <b>NH 77974 24060</b></p> <p>Lower section of <i>Allt Lathach</i> looking d/s.                      5m wide, 30cm depth. large amount of deposited boulders.</p>

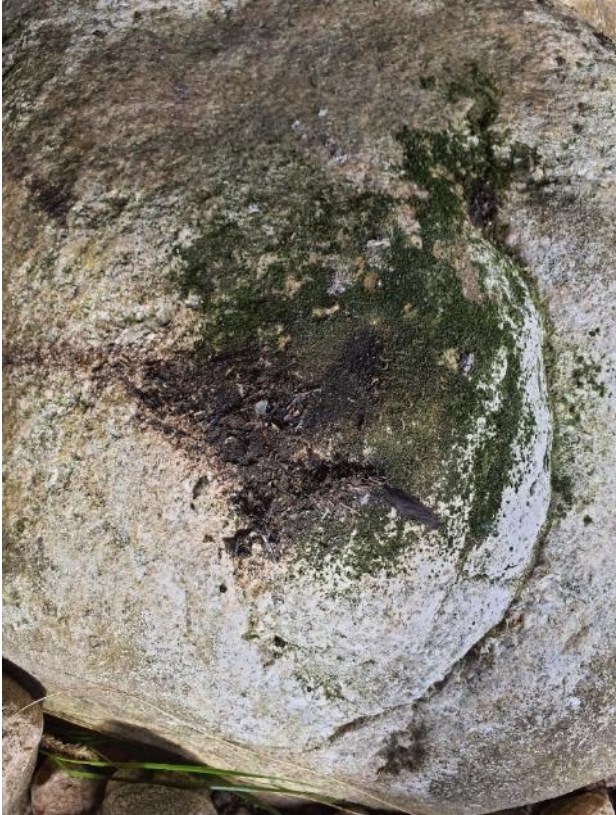
Target Note description	Photo
<p><b>TN 18 Photo 18</b>  <b>Grid ref:</b>  <b>NH7774824305</b>                      Lower section <i>Allt Lathach</i>. Incidental old otter spraint under bridge.</p>

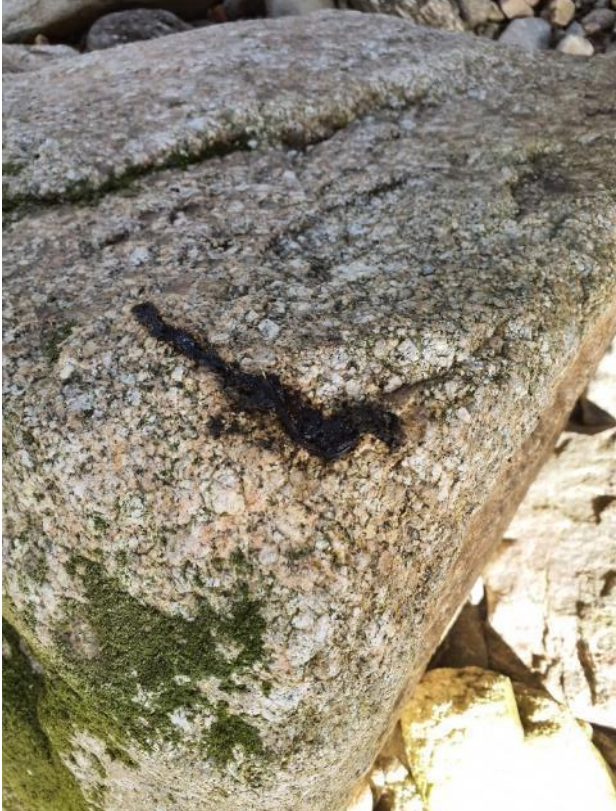
<p><b>TN19 Photo 19</b>  <b>Grid ref:</b>  <b>NH 77748 24303</b>                      Lower section <i>Allt Lathach</i>. Incidental second old otter spraint under bridge.</p>

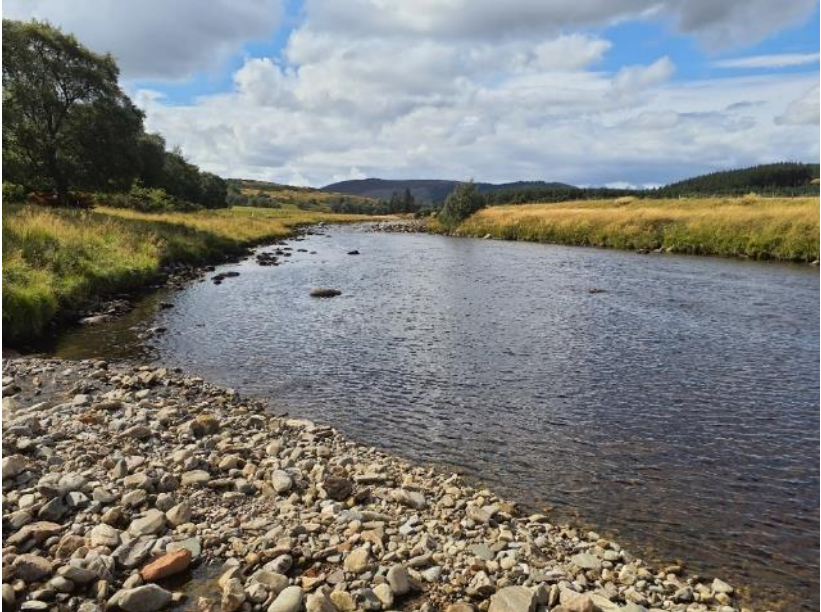
Target Note description	Photo
<p><b>TN20 Photo 20</b>  <b>Grid ref:</b>  <b>NH 77747 24428</b>                      River Findhorn looking u/s at end of Allt Lathach. 20m wide, 1m average depth. Slow run/glide with excellent fish habitat.</p>

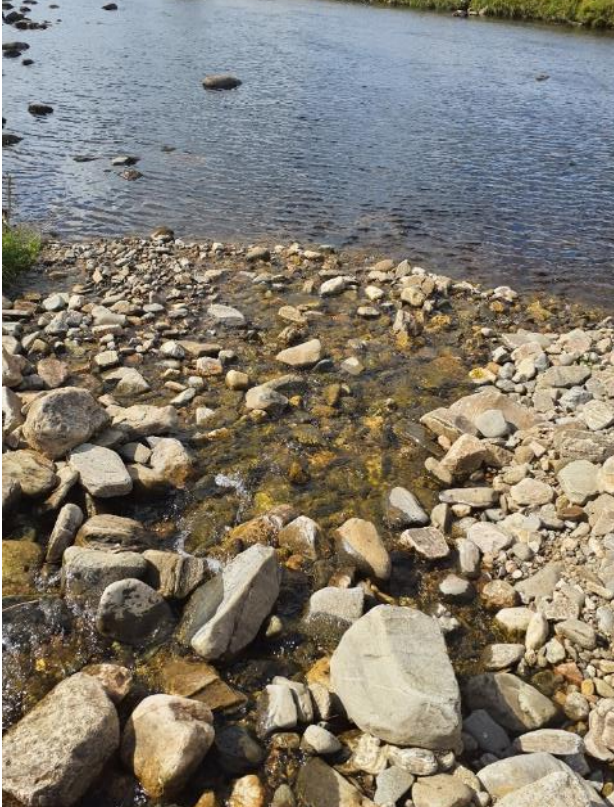
<p><b>TN21 Photo 21</b>  <b>Grid ref:</b>  <b>NH 77742 24426</b>                      End of <i>Allt Lathach</i> looking d/s towards River Findhorn. Large build up of sediment blocking migration during low flows.</p>

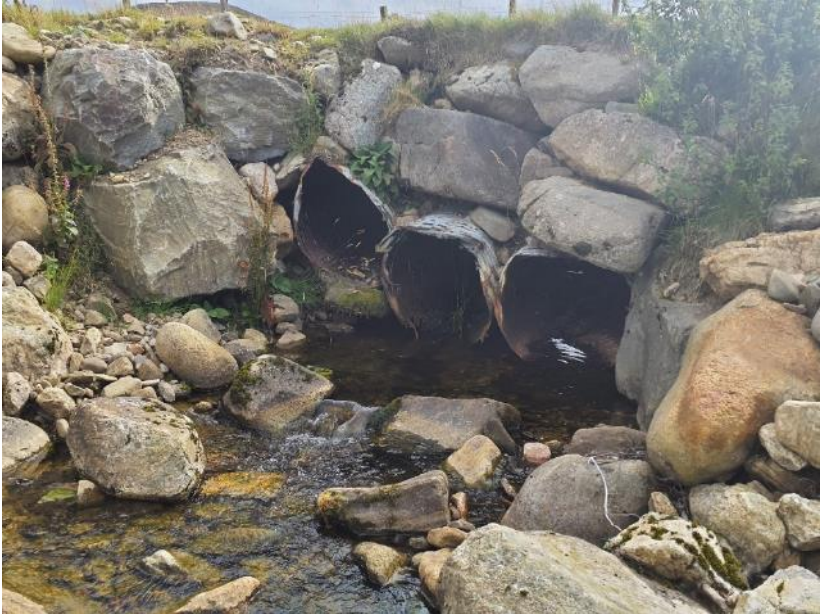
Target Note description	Photo
<p><b>TN22 Photo 21</b>  <b>Grid ref:</b>  <b>NH 77233 24215</b>                      End of Wester Strathnoon Burn looking u/s. Triple pipe culvert which is impassable during low flow.</p>

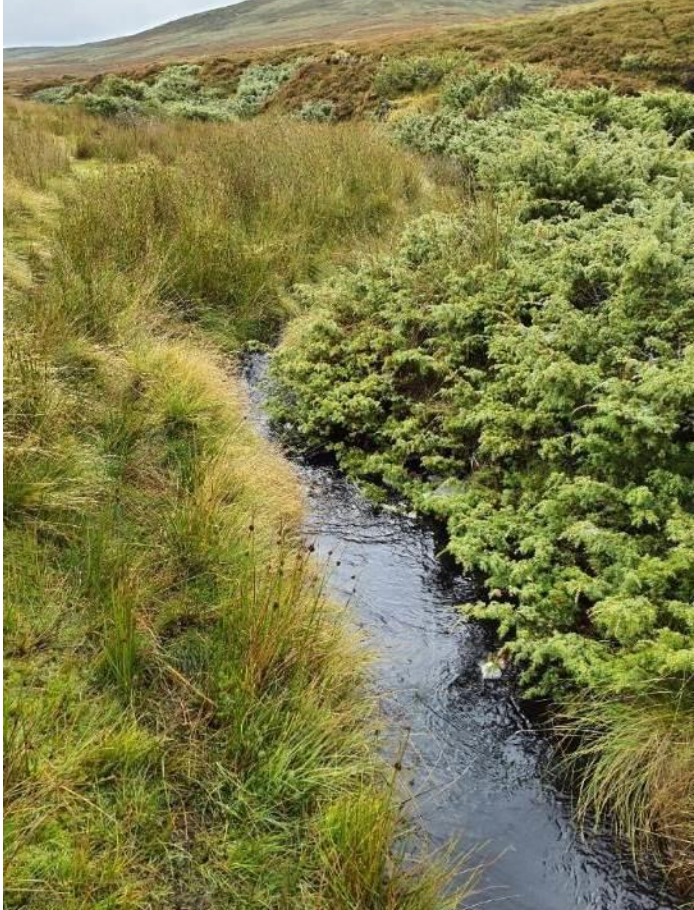
<p><b>TN 23 Photo 23</b>  <b>Grid ref:</b>  <b>NH 80491 24078</b>                      Mid-section of Clune Burn looking d/s. Run with good parr habitat and overhanging vegetation providing cover.</p>

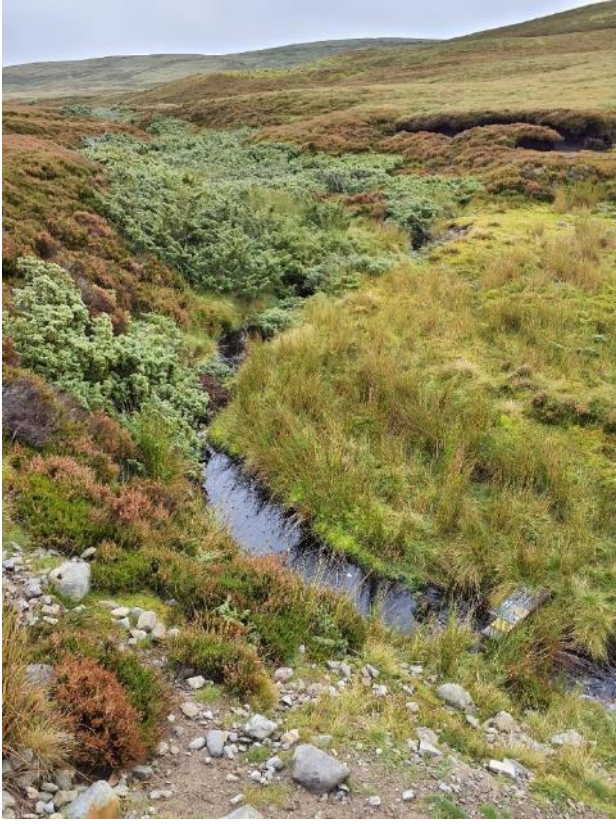
Target Note description	Photo
<p><b>TN26 Photo 26</b>  <b>Grid ref:</b>  <b>NH 80879 23542</b>                      Upper section of Clune Burn looking u/s. Good parr habitat, run, 1m wide.</p>

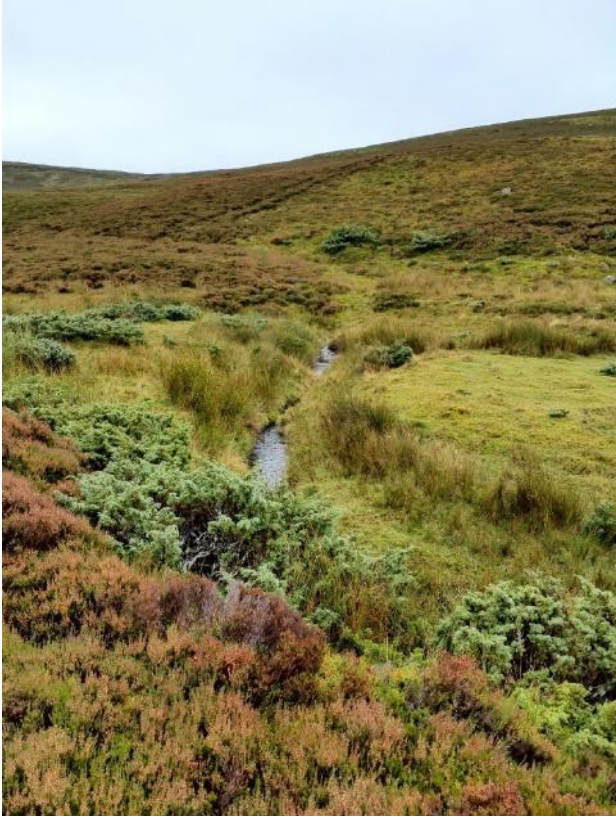
<p><b>TN27 Photo 27</b>  <b>Grid ref:</b>  <b>NH 81012 23292</b>                      Upper section of Clune Burn looking u/s. Good parr habitat, run, 80cm wide.</p>

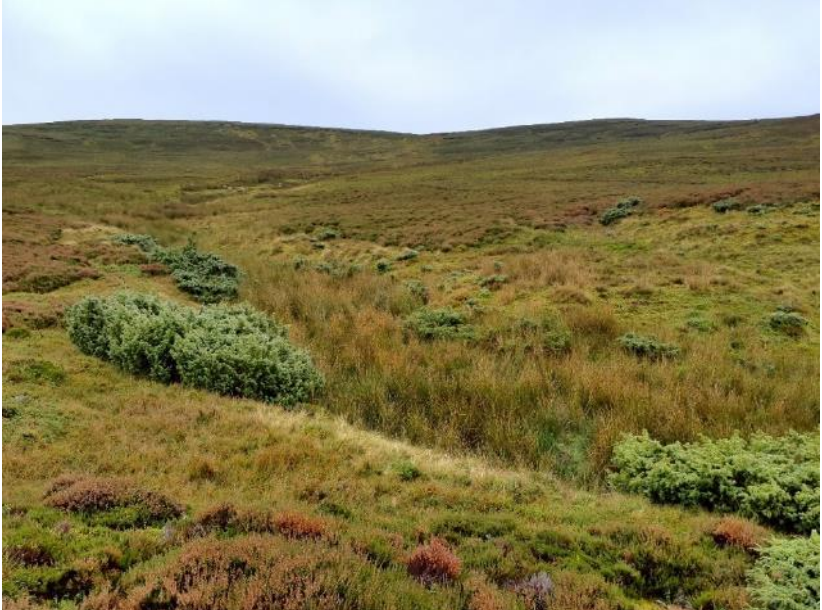
Target Note description	Photo
<p><b>TN28 Photo 28</b>  <b>Grid ref:</b>  <b>NH 81162 23109</b>                      Upper section of Clune Burn looking u/s. Run choked by rushes. Adequate parr habitat.</p>	 
<p><b>TN29 Photo 29</b>  <b>Grid ref:</b>  <b>NH 81139 23094</b>                      Upper section of Clune Burn looking u/s. Run choked by rushes. Low-quality fish habitat.</p>

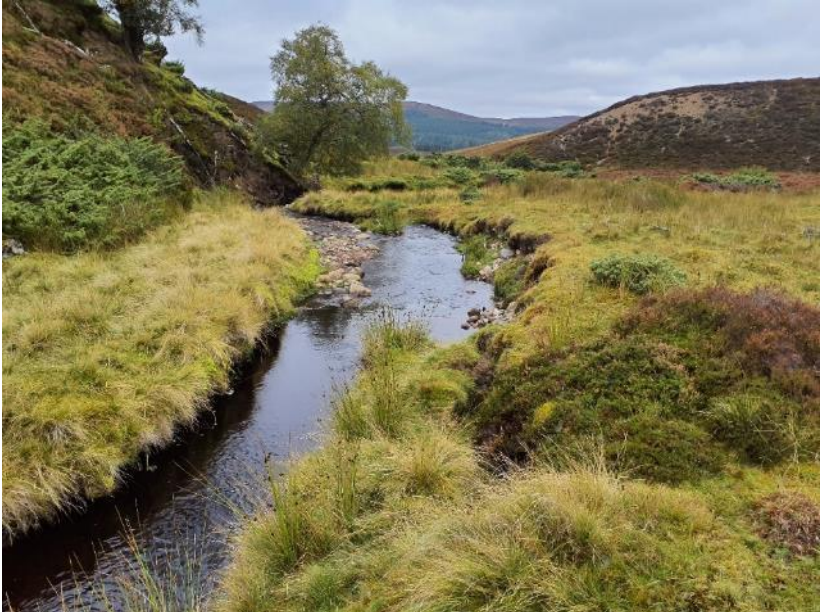
Target Note description	Photo
<p><b>TN32 Photo 32</b>  <b>Grid ref:</b>  <b>NH 80201 24372</b>                      Mid section of Clune Burn looking d/s. Run, 2m wide, 20cm deep.</p>

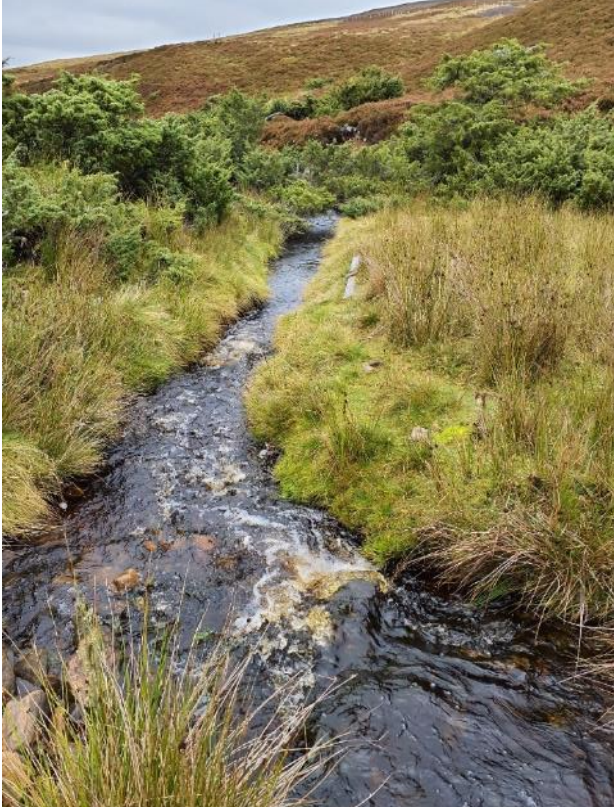
<p><b>TN33 Photo 33</b>  <b>Grid ref:</b>  <b>NH 80119 24442</b>                      Mid section of Clune Burn looking d/s. Run, 1m wide, 10cm deep. Good fry and parr habitat.</p>

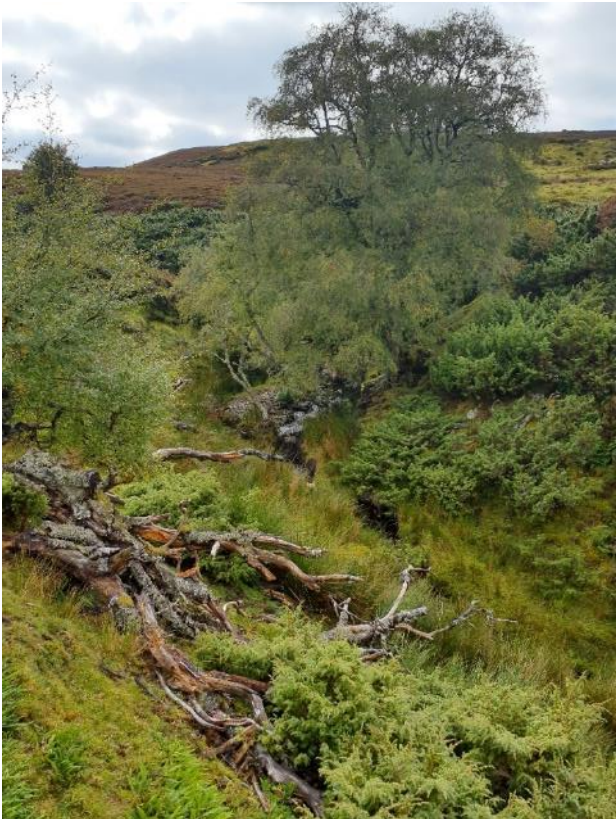
Target Note description	Photo
<p><b>TN36 Photo 36</b>  <b>Grid ref:</b>  <b>NH 81206 25309</b>                      Mid section <i>Allt Phris</i> looking u/s. 1m wide run with high-quality habitat, tree cover and debris in channel.</p>

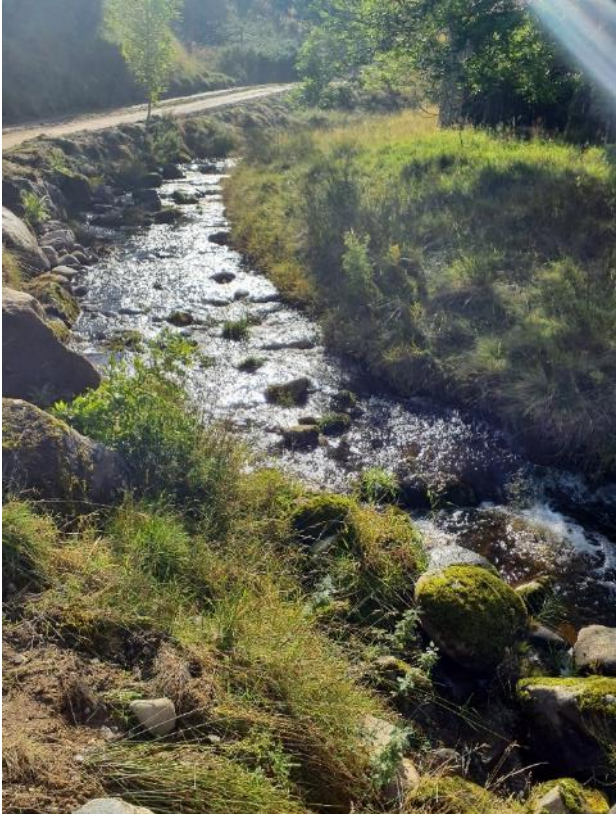
Target Note description	Photo
<p><b>TN 40 Photo 40</b>  <b>Grid ref:</b>  <b>NH 79443 25705</b>                      Lower section Clune Burn looking u/s. 2m wide run, 30cm deep, some bankside reinforcement, good parr habitat.</p>

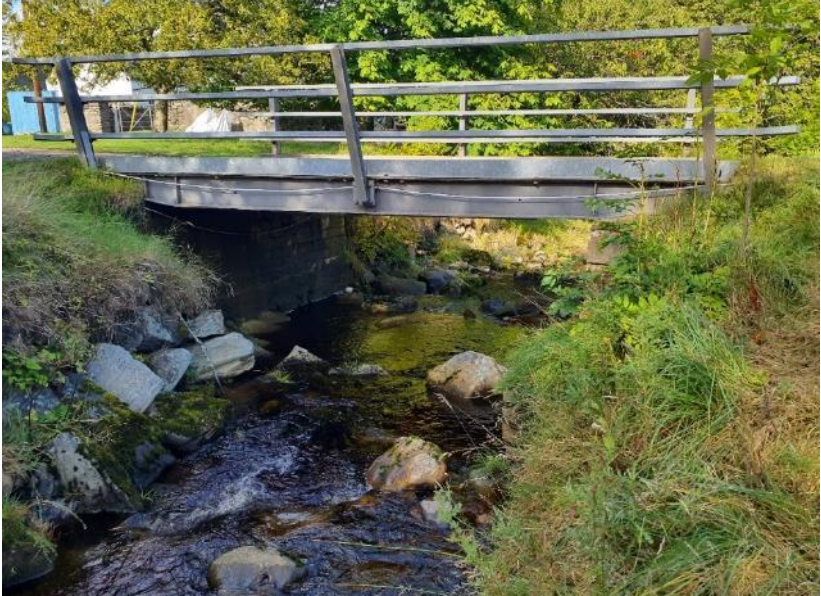
<p><b>TN 41 Photo 41</b>  <b>Grid ref:</b>  <b>NH 79440 25714</b>                      Lower section Clune Burn looking d/s. Road bridge, fully passable.</p>

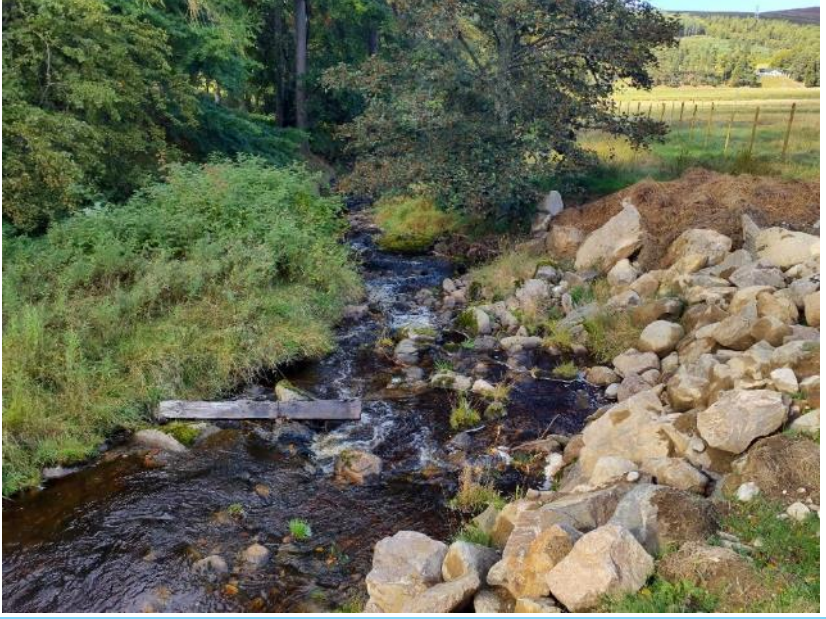
Target Note description	Photo
<p><b>TN 42 Photo 42</b>  <b>Grid ref:</b>  <b>NH 79472 25769</b>                      Lower section Clune Burn looking d/s. 3m wide run, high-quality parr habitat.</p>

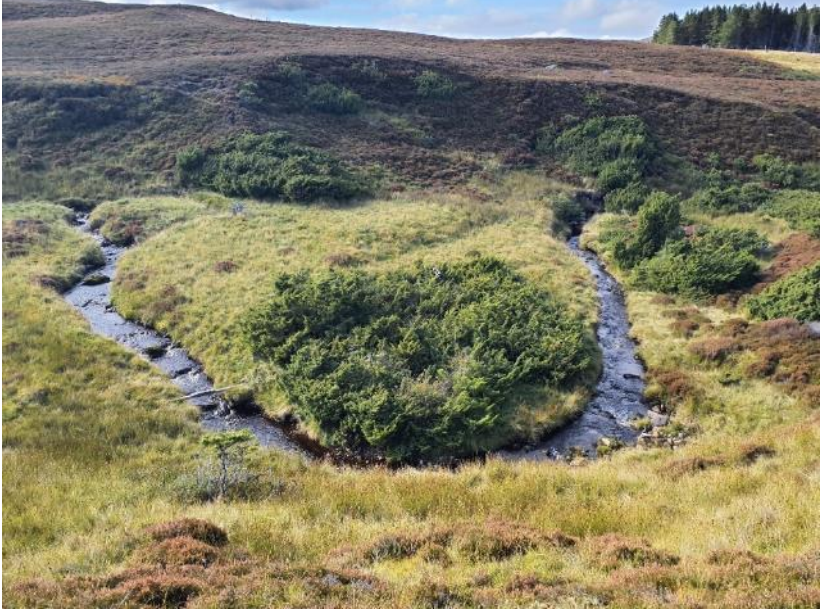
<p><b>TN 43 Photo 43</b>  <b>Grid ref</b>  <b>NH 79549 25280</b>                      Lower section of Clune Burn looking d/s. 1m wide run, 30cm deep, good parr habitat with some boulders in stream.</p>

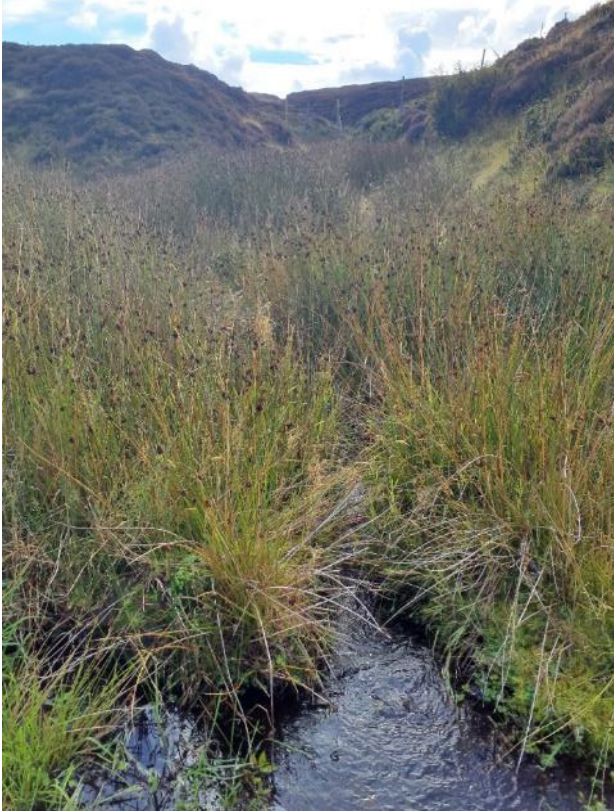
Target Note description	Photo
<p><b>TN 44 Photo 44</b>  <b>Grid ref:</b>  <b>NH 79738 24770</b>                      Lower section Clune burn looking u/s. High-quality habitat, run 1m wide, cobbles instream.</p>	 
<p><b>TN 45 Photo 45</b>  <b>Grid ref:</b>  <b>NH 79726 24717</b>                      Lower section of Clune Burn at unnamed tributary looking u/s. Overgrown channel with rush. Low-quality habitat.</p>

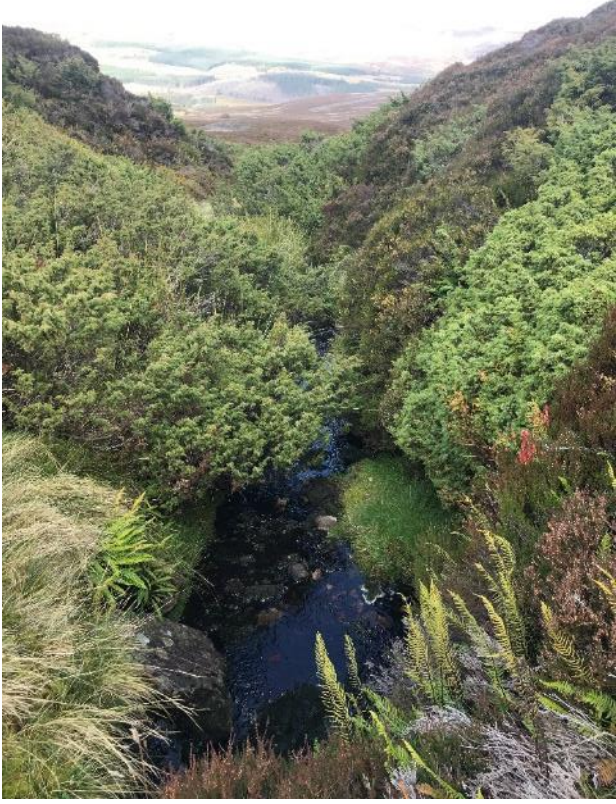
Target Note description	Photo
<p><b>TN 46 Photo 46</b>  <b>Grid ref:</b>  <b>NH 77086 22677</b>                      Upper section of <i>Caochan a' Phuill</i> looking d/s. 1m wide run, high-quality habitat with instream cobbles and bankside vegetation.</p>

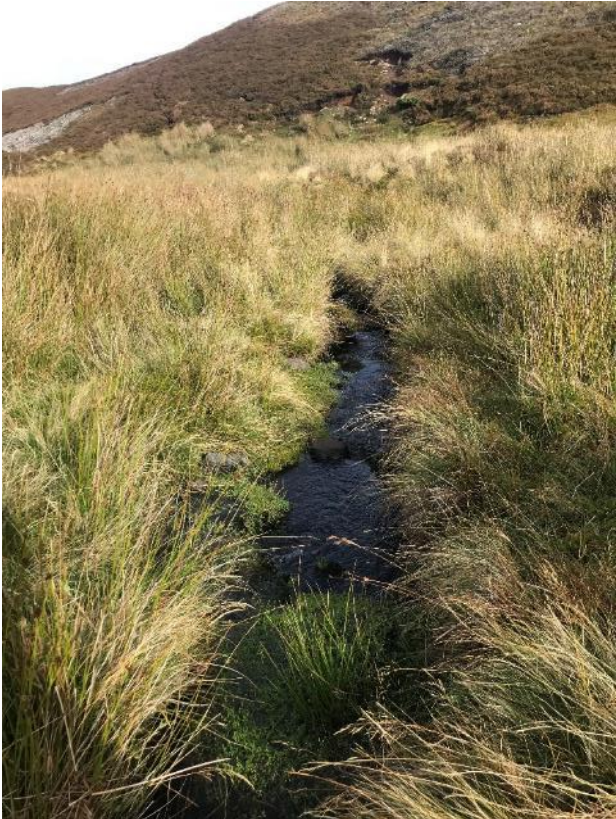
<p><b>TN 47 Photo 47</b>  <b>Grid ref:</b>  <b>NH 77092 22838</b>                      Upper section of <i>Caochan a' Phuill</i> looking d/s. 1m wide run, good quality habitat with instream cobbles.</p>

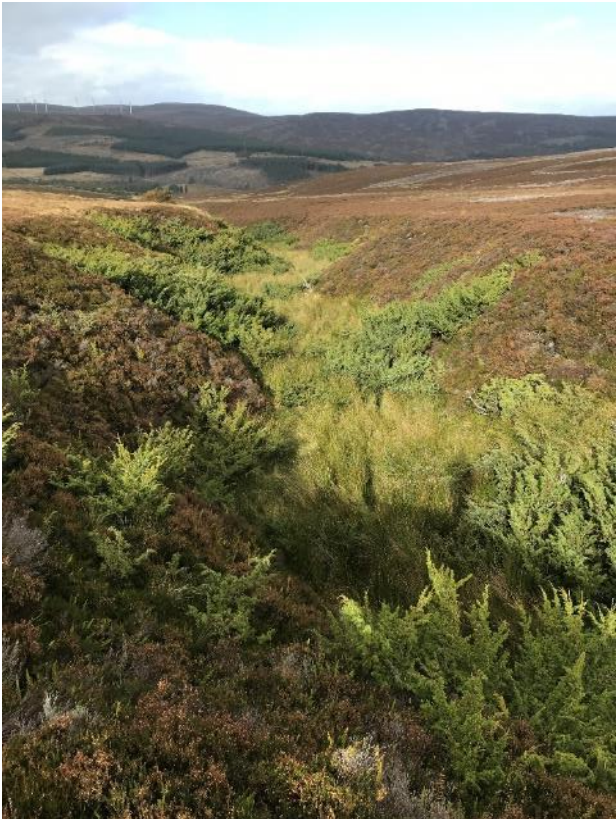
Target Note description	Photo
<p><b>TN 48 Photo 48</b>  <b>Grid ref:</b>  <b>NH 77006 23048</b>                      Upper section of <i>Caochan a' Phuill</i> looking d/s. Low-quality habitat choked with rushes. Possibly impassable in low flows.</p>

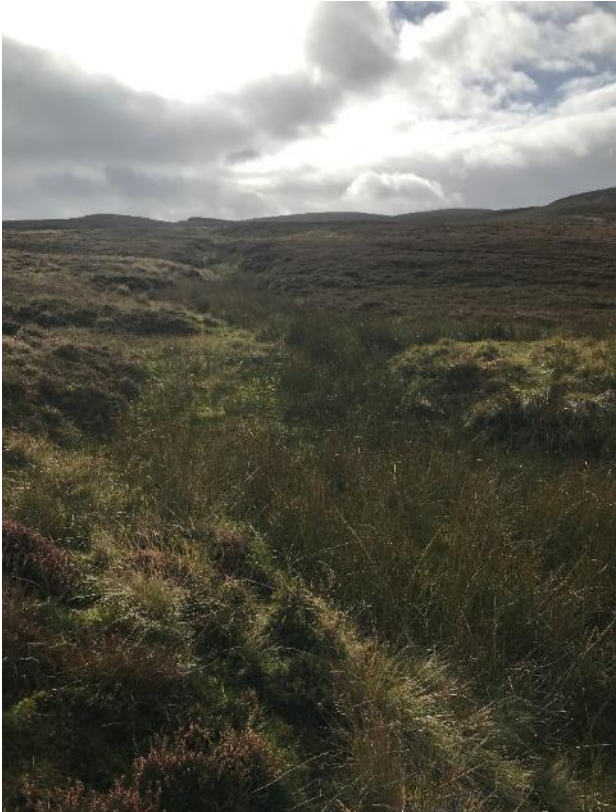
<p><b>TN 49 Photo 49</b>  <b>Grid ref:</b>  <b>NH 76878 23336</b>                      Upper section of <i>Caochan a' Phuill</i> looking u/s. Low-quality habitat choked with rushes. Possibly impassable in low flows.</p>

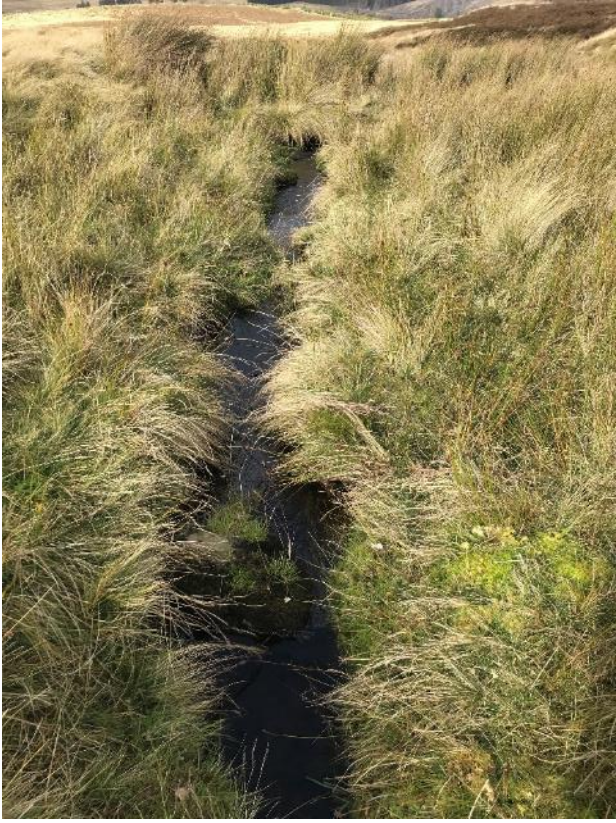
Target Note description	Photo
<p><b>TN 50 Photo 50</b> <b>Grid ref:</b> <b>NH 76871 23344</b> Upper section of <i>Caochan a' Phuill</i> looking d/s. 80cm wide run with some instream rocks. Good quality fry habitat.</p>

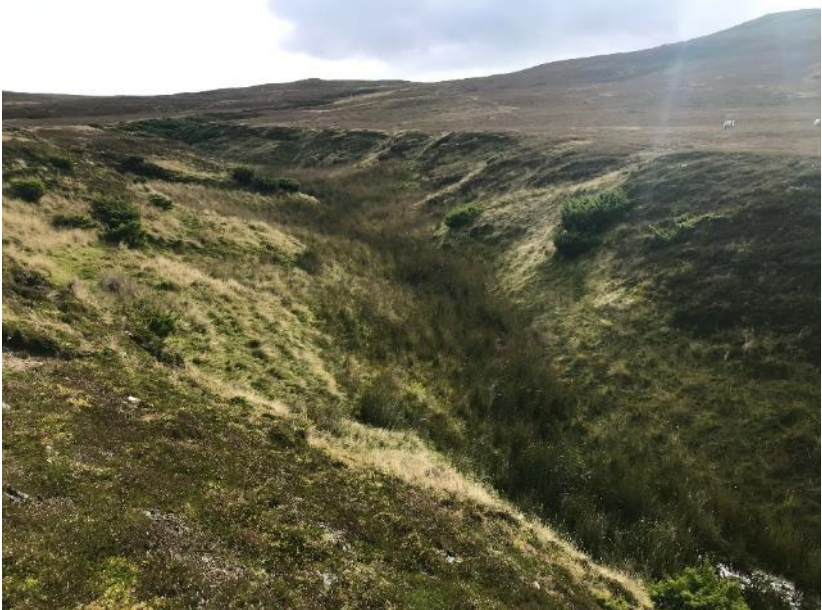
Target Note description	Photo
<p><b>TN 52 Photo 52</b>  <b>Grid ref:</b>  <b>NH 76536 23568</b>                      Upper section                      Caochan Seachdag                      looking u/s.                      Low-quality habitat                      choked with rushes.                      Possibly impassable in                      low flows.</p>
