Technical Appendix 9.1: Peat Landslide Hazard Risk Assessment

Clune Wind Farm

Renewable Energy Systems Ltd

SLR Consulting Limited

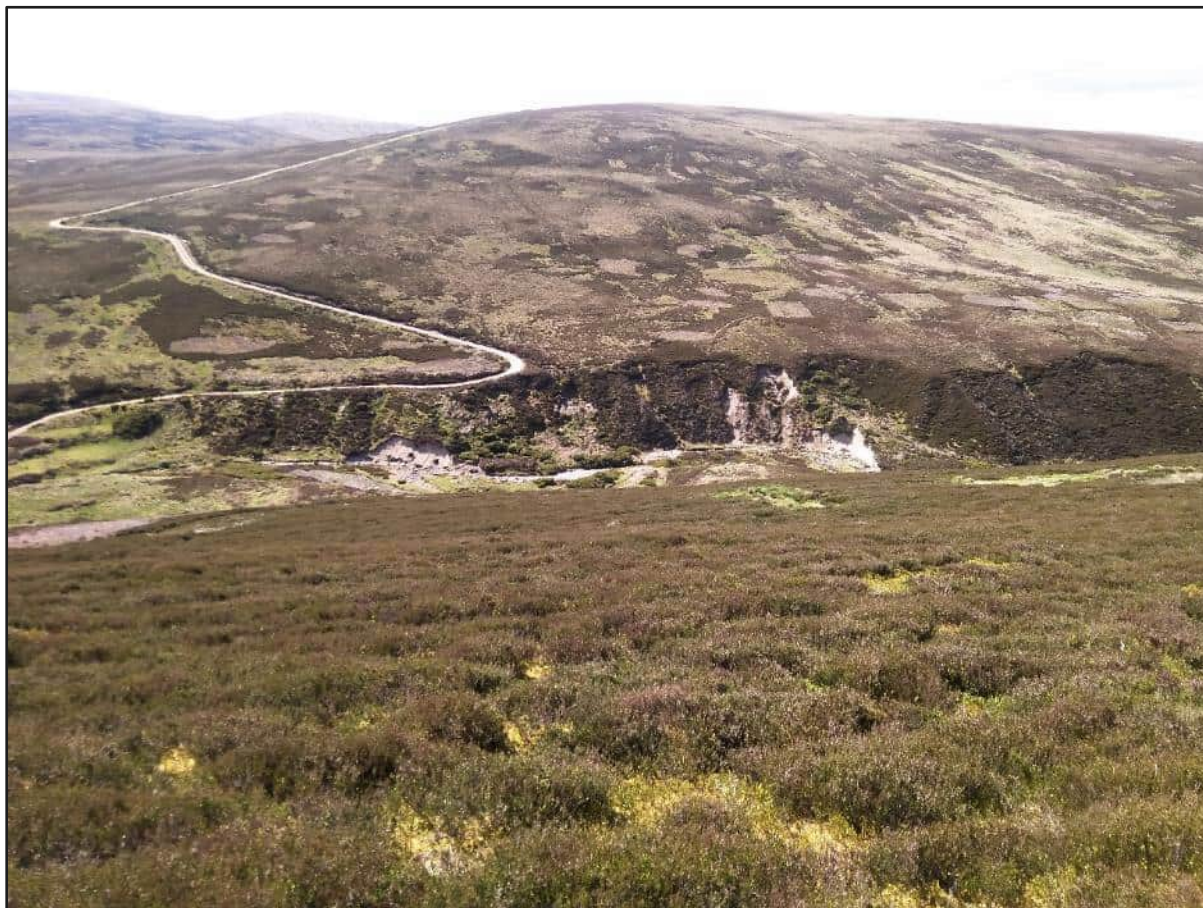
Plate 1: Gulley and steep slopes at Carn Ruighe Shamhraich, looking west from Carn Coire na Cluanaich . National Grid Reference (NGR): NH 79564 22434.

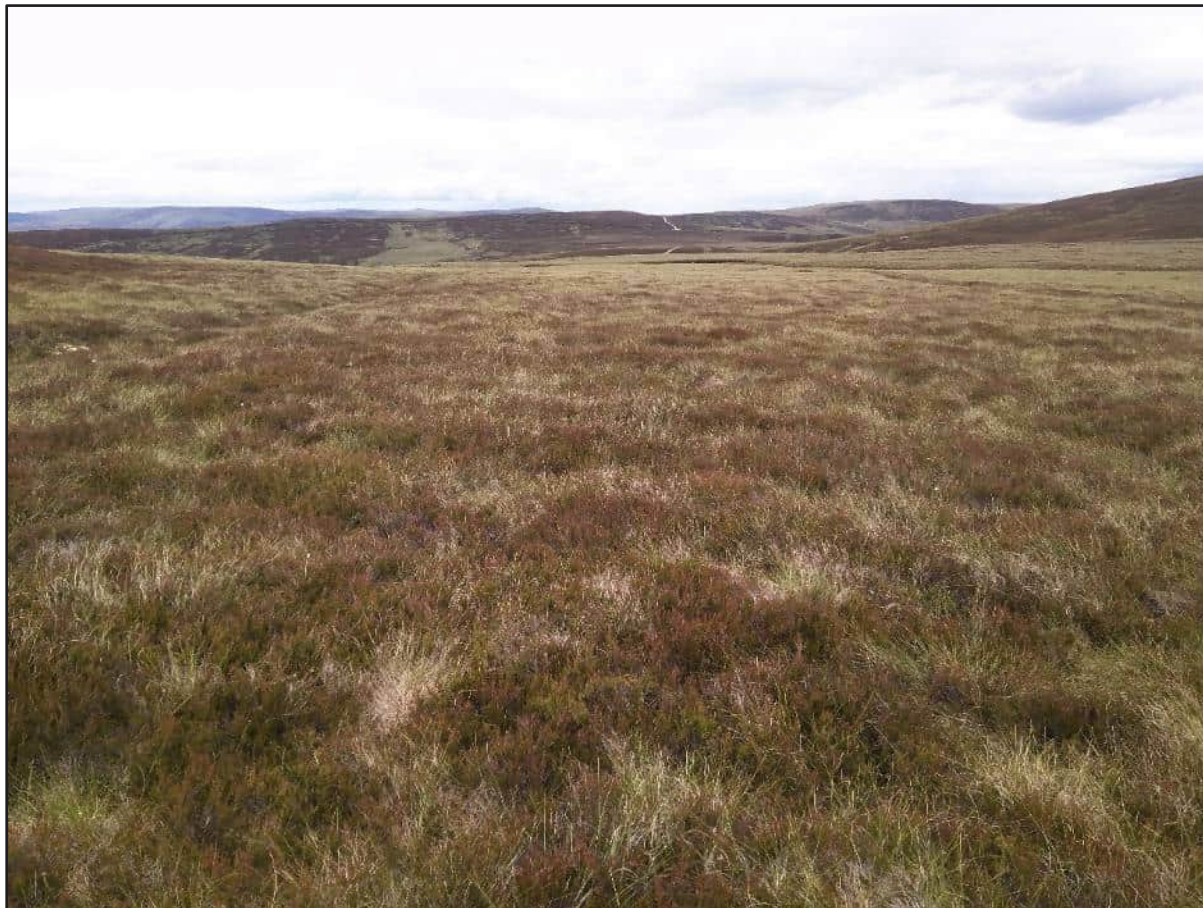
Peat deposits are common throughout the Proposed Development, with areas of deep peat noted across the majority of the Proposed Development. There is an area of extensive blanket bog in west of the Proposed Development near Carn Bad an Daimh, peat depths of over 2m were recorded. Blanket bog was also surveyed north of T20, with over 2m of peat being recorded. There are localised hollows of blanket bog across the Proposed Development which occur at breaks of slopes. The borrow pit search area located directly east of T18 had small peat hollows present on the southern slopes. An area of localised peat bog is situated at the south-west slope of Carn a' Gharbh-choire within the break in slope before topography begins to steepen towards Carn na Glaic Fhluich.

Plate 2: Extensive blanket peat bog located east of Carn Bad an Daimh looking northeast. NGR: NH 76881 21680.

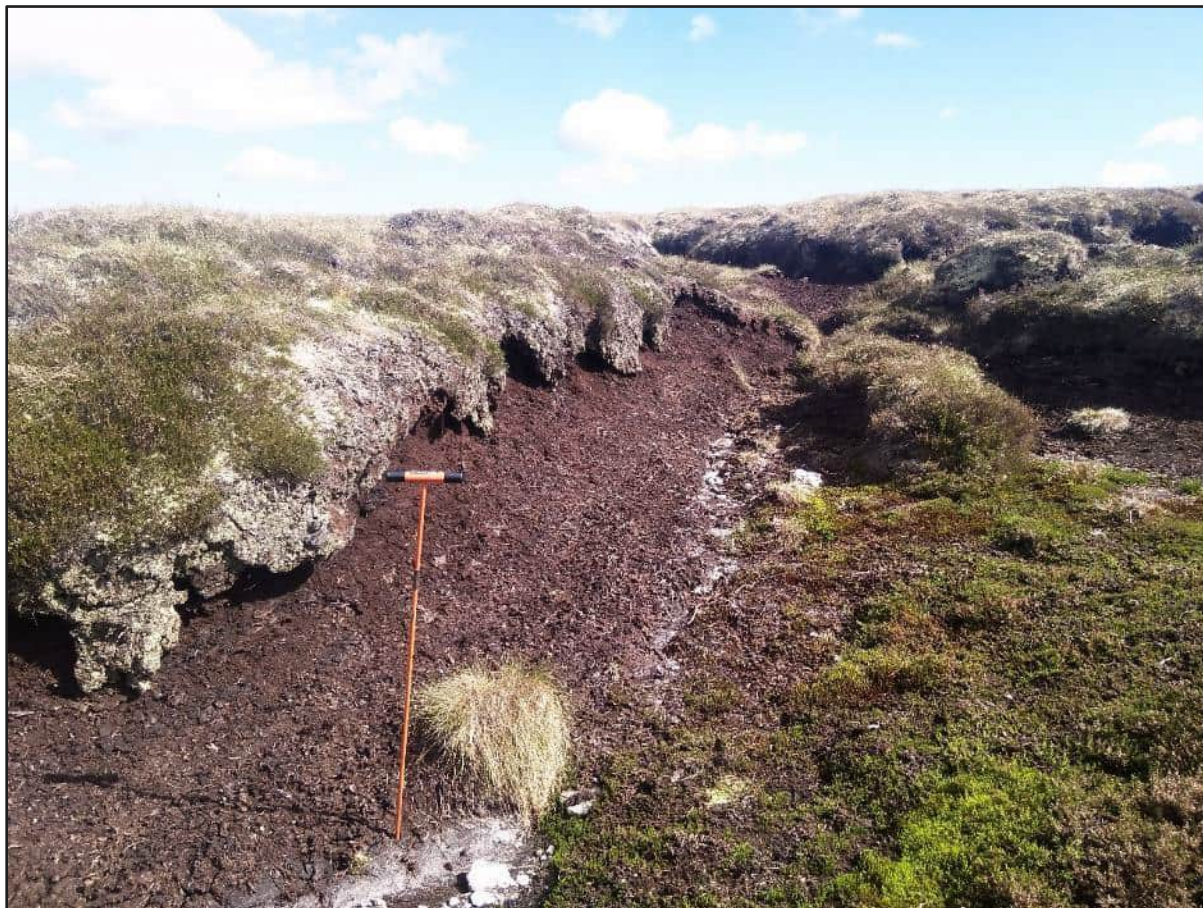
There are extensive areas of peat haggging across the Proposed Development. Peat hagggs were seen on the flanks of Carn Core na Cluanaich (north-east of T12) with exposed hagggs up to 2.5m in height. The west of the Proposed Development also has extensive erosional features with largescale haggging recorded on the east slopes of Carn Bad an Daimh near T26 with hagggs of 1.8m-2m measured. Peat hagggs were observed at T2 related to active erosion on the north-west of Carn Mheadhoin. T15 also had extensive peat hagggs with peat depths of 1.2m measured.

Plate 3: Peat hagsgs near T15 looking south-west. NGR: NH 78311 20942.

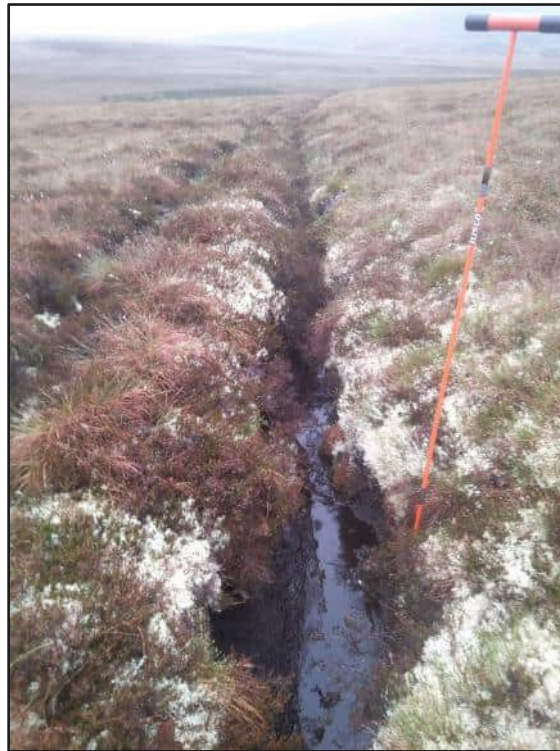
The Proposed Development features extensive artificial drainage that generally trend north to south. These drainage ditches were recorded up to 1m deep and 0.8m wide. In some areas drainage was recorded as trending east to west, particularly at the south of T15, this was related to slope direction. Peat cuttings were also noted during surveys, predominantly south-west of Carn a' Gharbh-choire.

Plate 4: Drainage ditch trending north-west to south-east at T13. NGR: NH 79564 22434

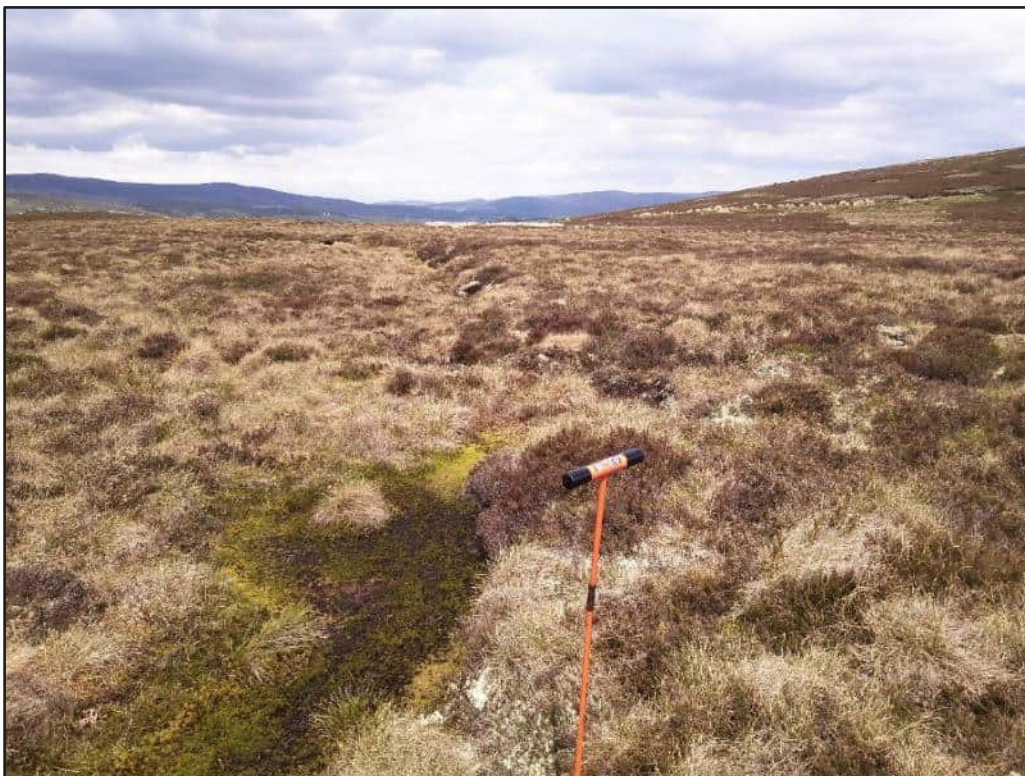
Plate 5: Peat cuttings south-west of Carn a' Gharbh-choire. NGR: NH 81910 25372.

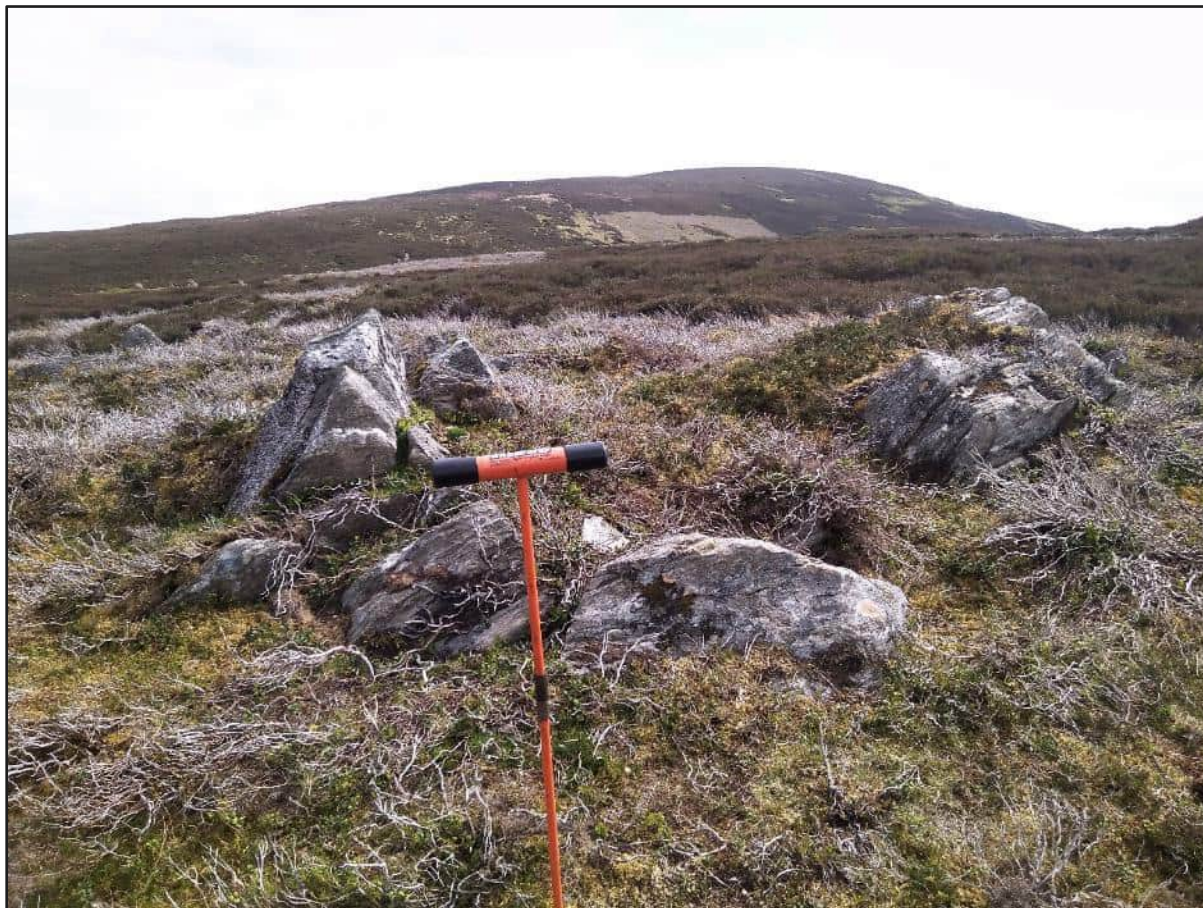
From review of aerial photography, bedrock outcrops are abundant across the Proposed Development. This was confirmed during Site walkovers where bedrock outcrops were frequently encountered. Bedrock was often seen on the tops of ridges and flatter tops, mostly bedrock was observed as weathered regolith or at near surface.

Plate 7: Bedrock south of Carn a' Phris, Mica Schist. NGR: NH 81408 25571.

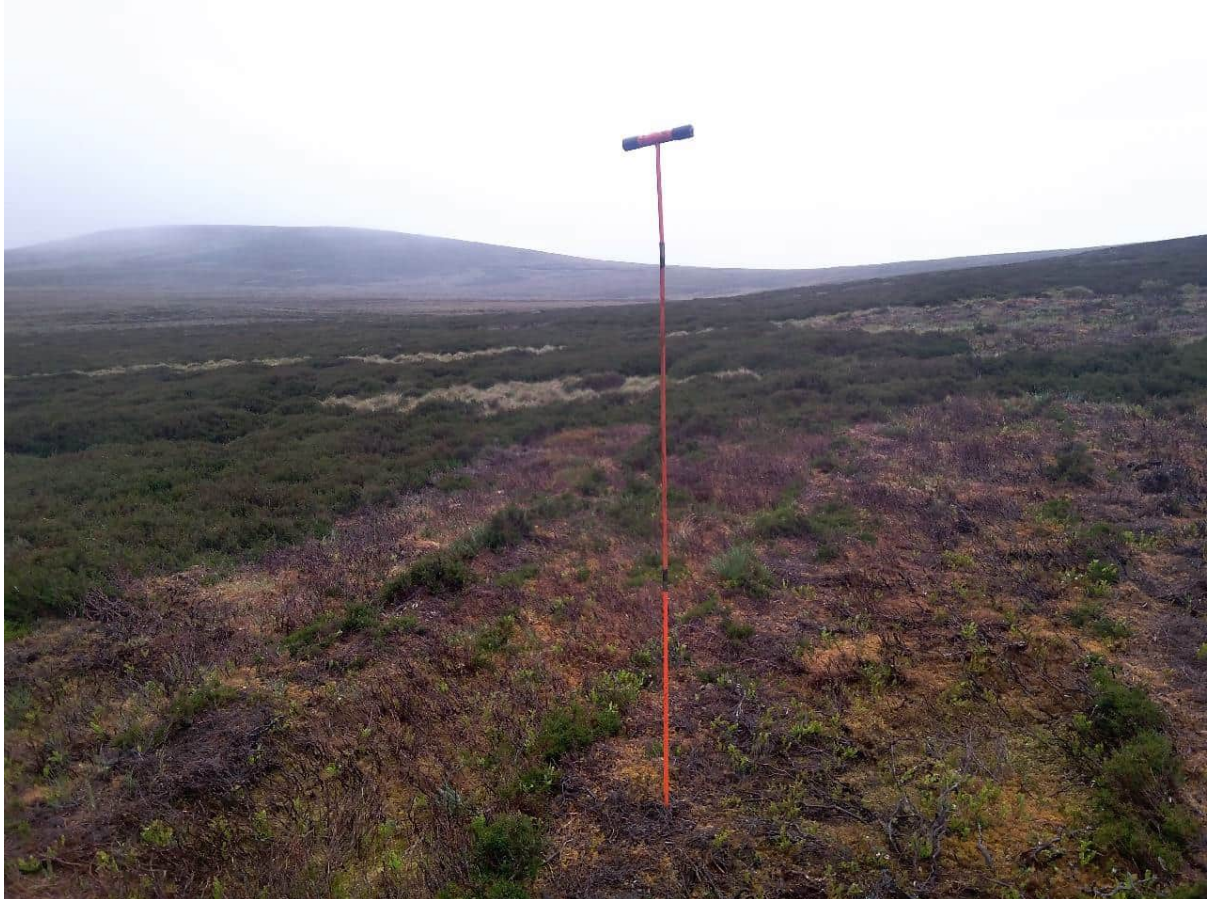
Plate 8: Prescribed burning of heather at T11, looking north from the south-west flanks of Carn Phris Mhoir. NGR: NH 80293 21670.

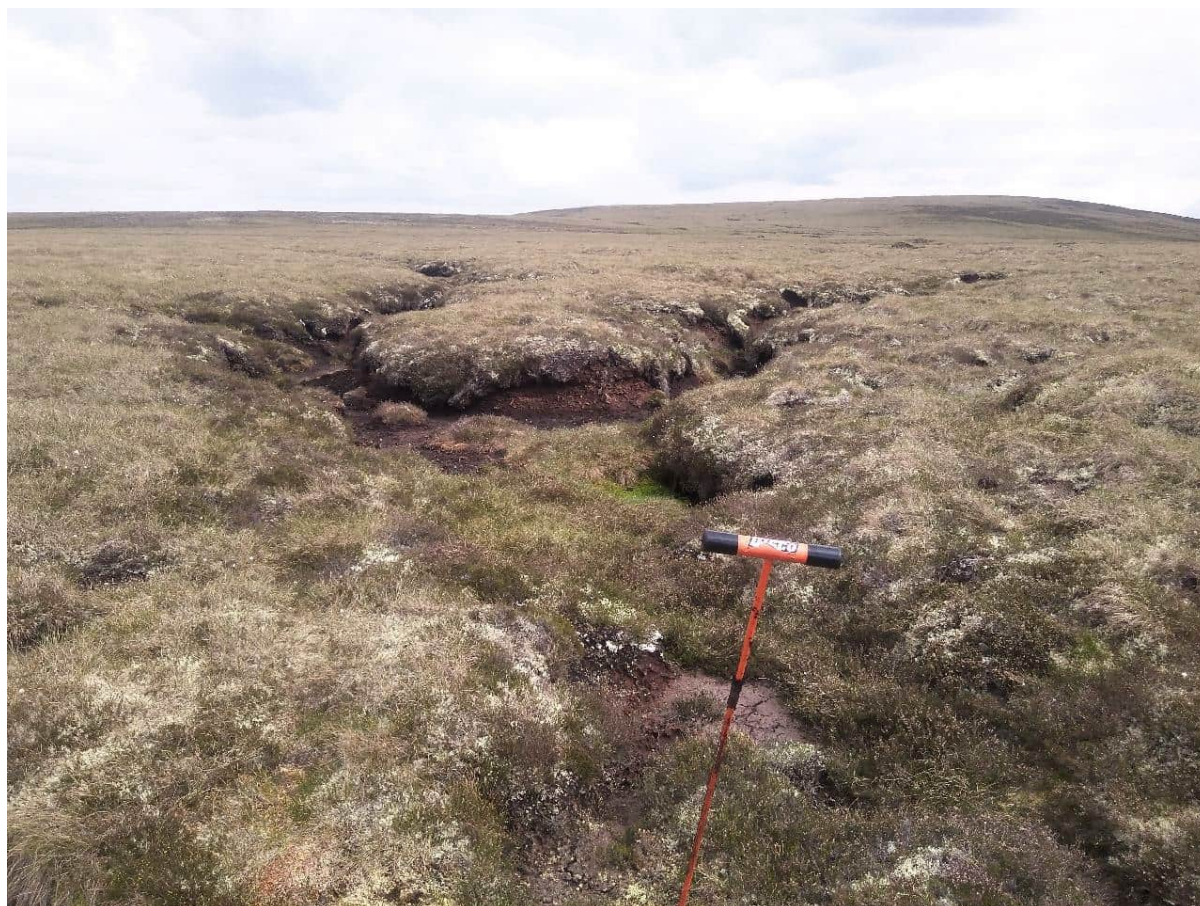
Plate 9: Actively eroding peat hagsgs, looking south. NGR: NH 80125 22572.

The majority of the Proposed Development peatland condition is drained and modified. Peat core logs and photographs are presented within **Annex B**.

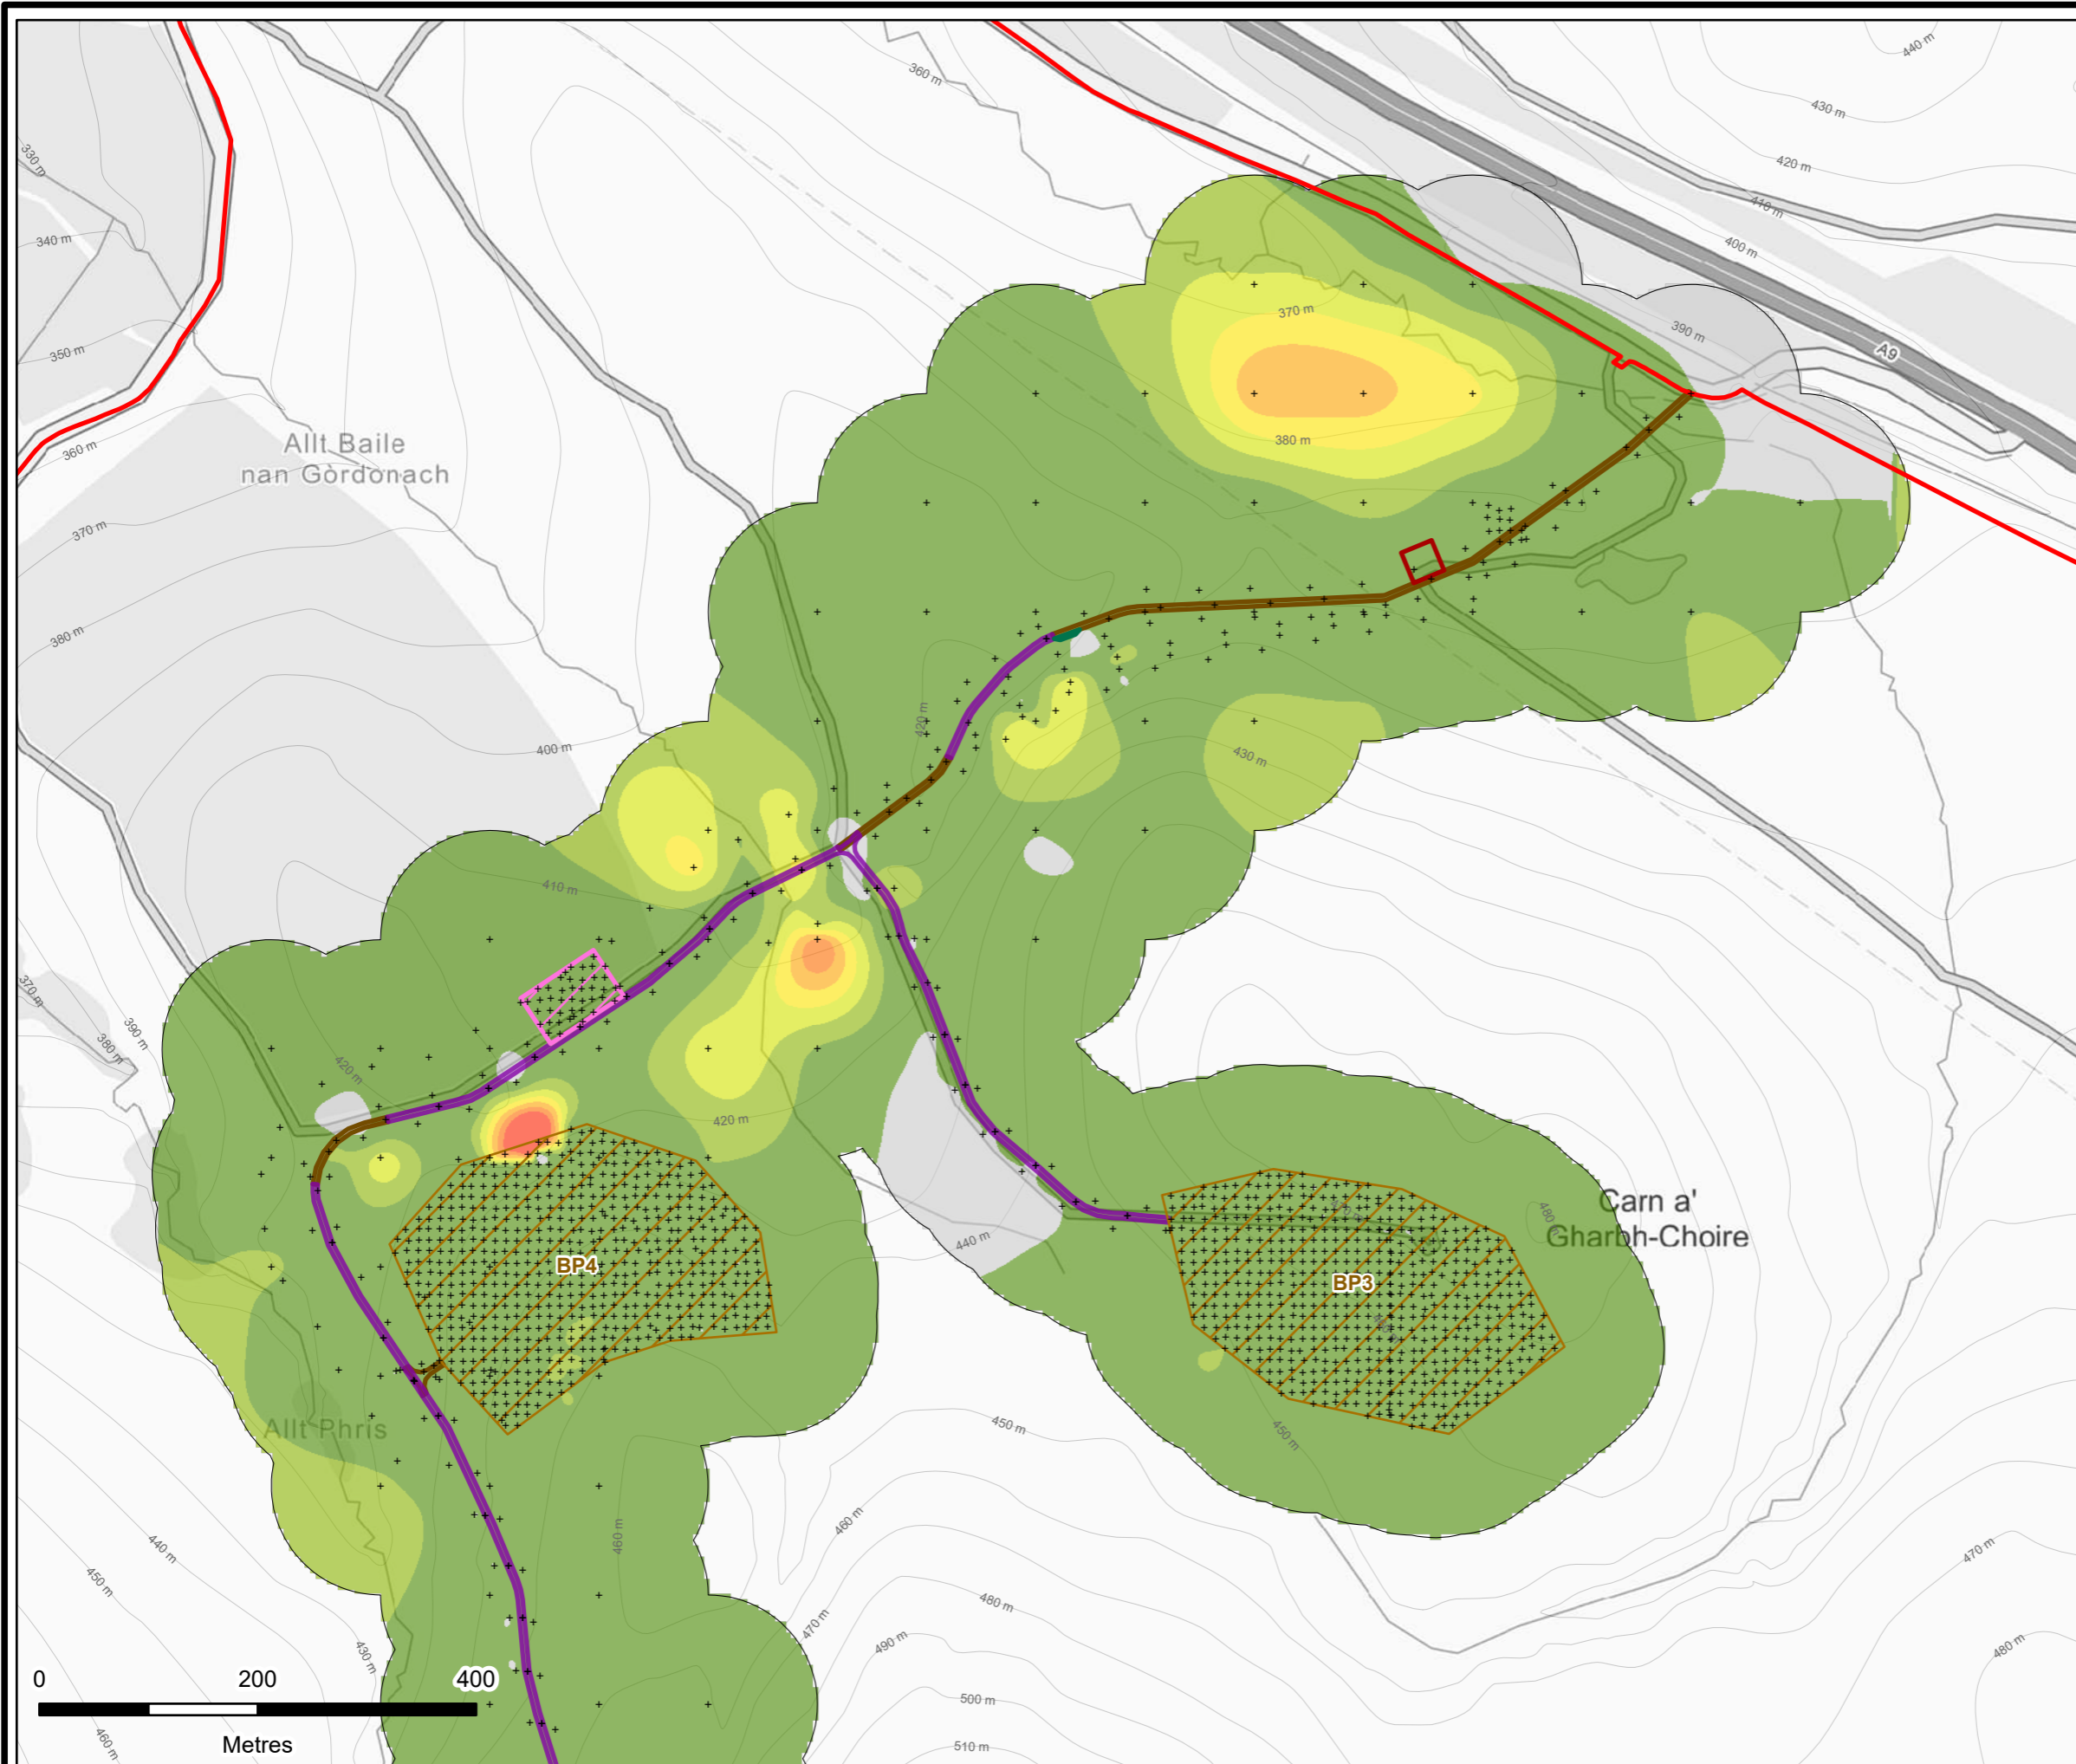
PEAT DEPTH

- Site Boundary
- Proposed Temporary Construction Compound
- Proposed Borrow Pit Search Area
- Proposed Gatehouse Compound
- Proposed Passing Place
- Proposed Site Track
- Existing Track to be Upgraded
- Peat Probe

Peat Depth (m)
