Table 5: Target Notes (Additional Area)

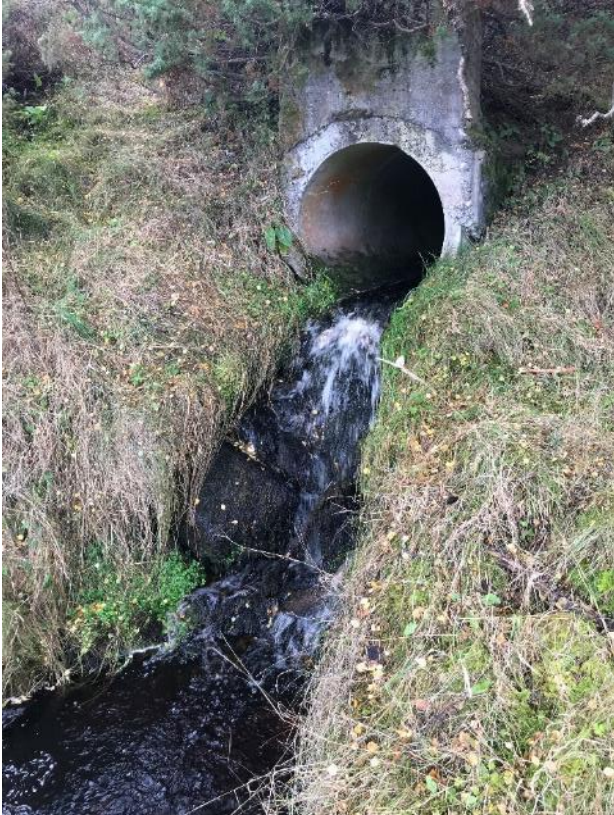
Target Note description	Photo
<p>TN 56 Photo 56 Grid ref: NH 76808 24115 Lower section Caochan Seachdag looking u/s. Pipe culvert with 1m high drop, impassable at low flows.</p>

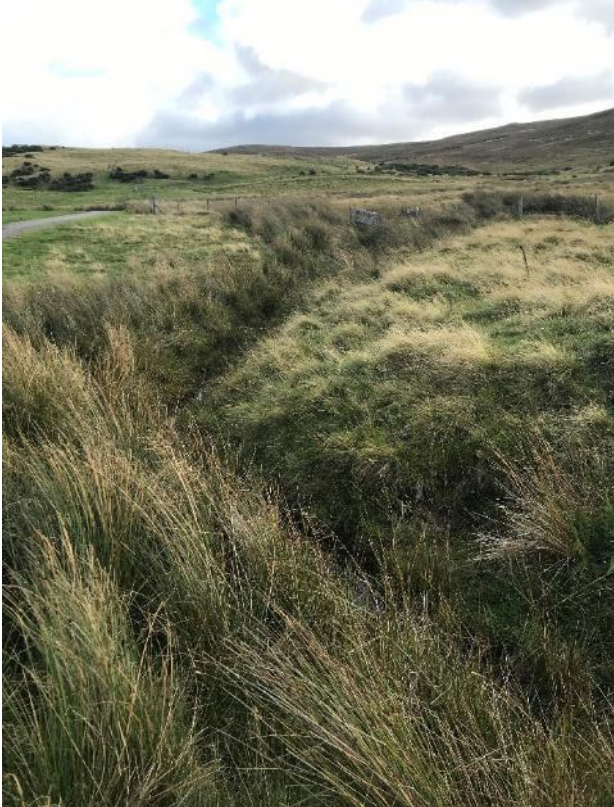
<p>TN 57 Photo 57 Grid ref: NH 76181 23972 Lower section of unnamed tributary of River Findhorn looking u/s. Low-quality ditch watercourse. Overgrown with rushes.</p>

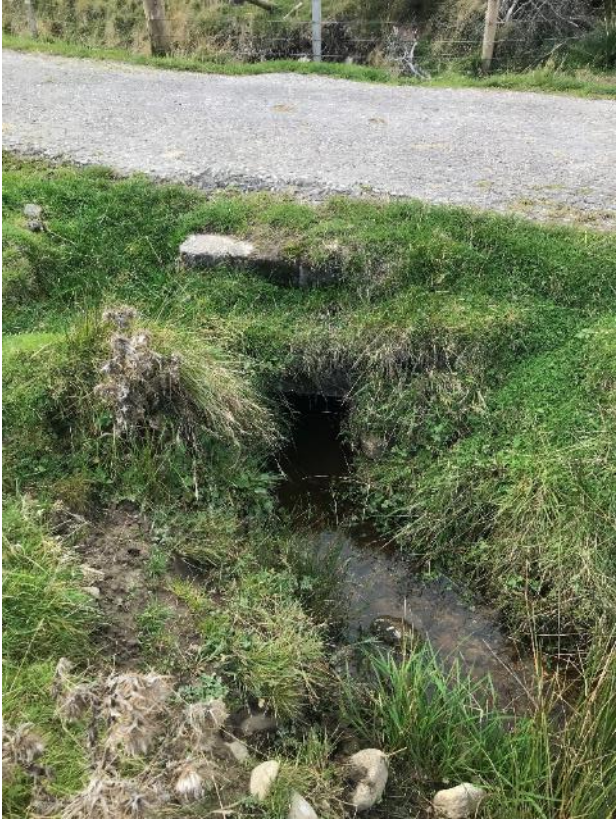
Target Note description	Photo
<p>TN 62 Photo 62 Grid ref: NH 75845 23742</p> <p>Lower section of unnamed tributary looking d/s. Stone culvert, possibly impassable in low flows.</p>

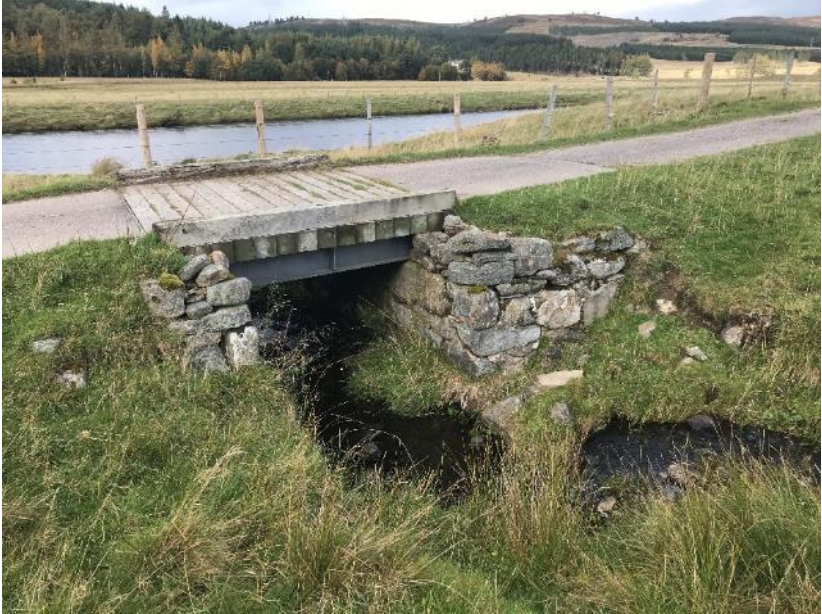
<p>TN 63 Photo 63 Grid ref: NH 75614 23551</p> <p>Lower section of unnamed tributary looking d/s. Bridge over watercourse.</p>

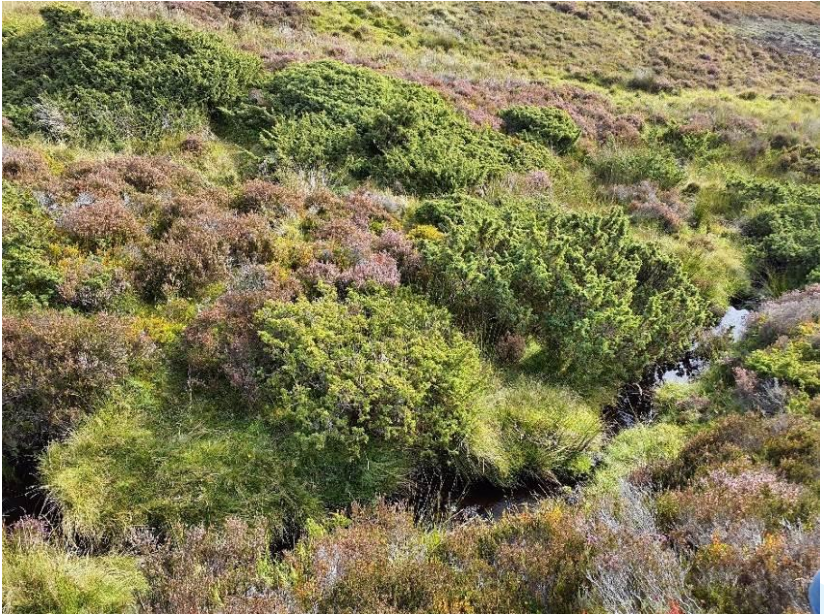
Target Note description	Photo
<p>TN69 Grid ref: NH8202121272 Ford, probably impassable.</p>

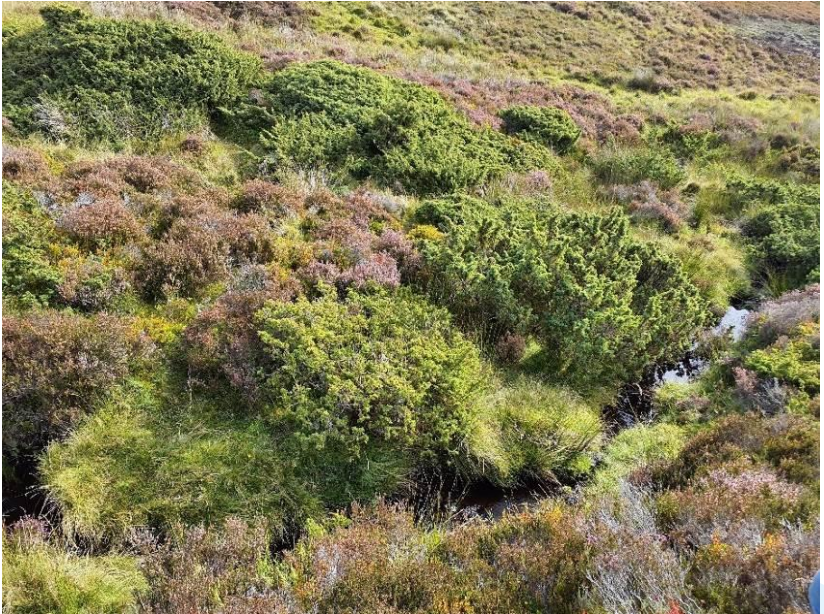
<p>TN70 Photo 69 Grid ref: NH8220021261 Narrow run, 30cm wide channel, 10cm deep. Fairly steep gradient. Overgrown channel in places - juniper and gorse.</p>

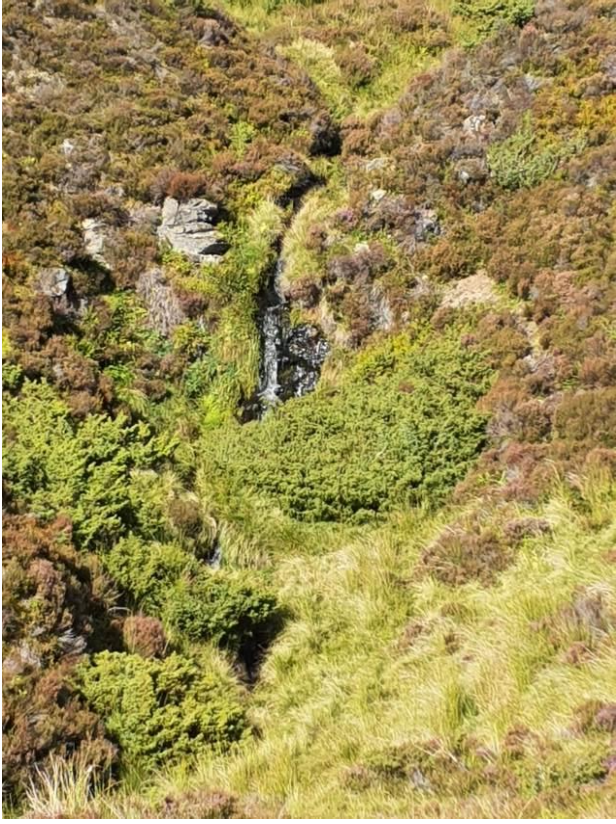
Target Note description	Photo
<p>TN71 Photo 70 Grid ref: NH8195121584 Steep falls section 3-4m from base to top. 30cm narrow channel through bedrock.</p>

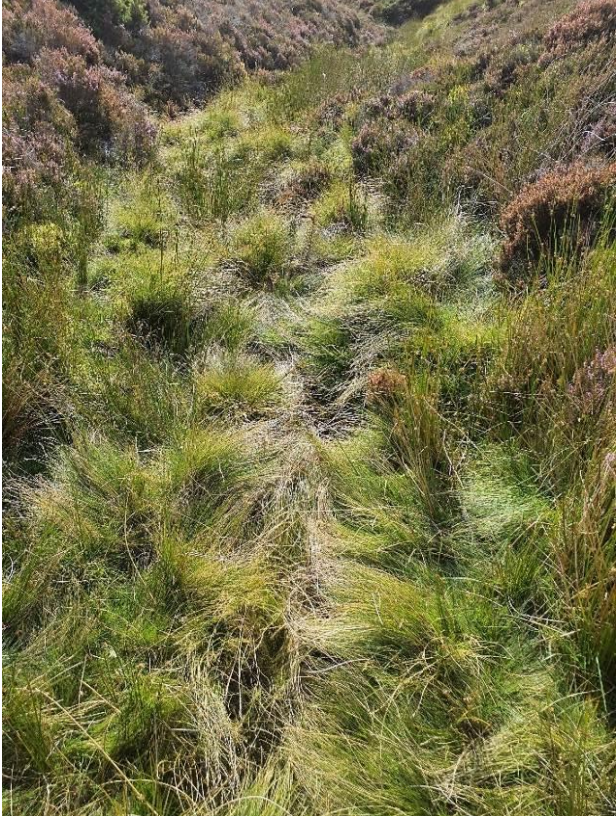
<p>TN72 Photo 71 Grid ref: NH8183421644 Overgrown channel juncus and grass growth.</p>

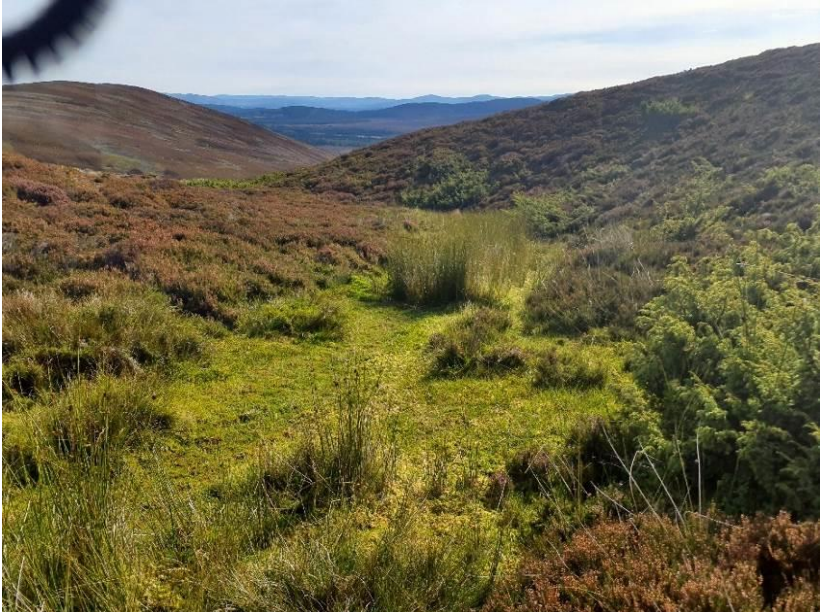
Target Note description	Photo
<p>TN73 Photo 72 Grid ref: NH8169921342 Dry channel juncus flush no fish interest.</p>

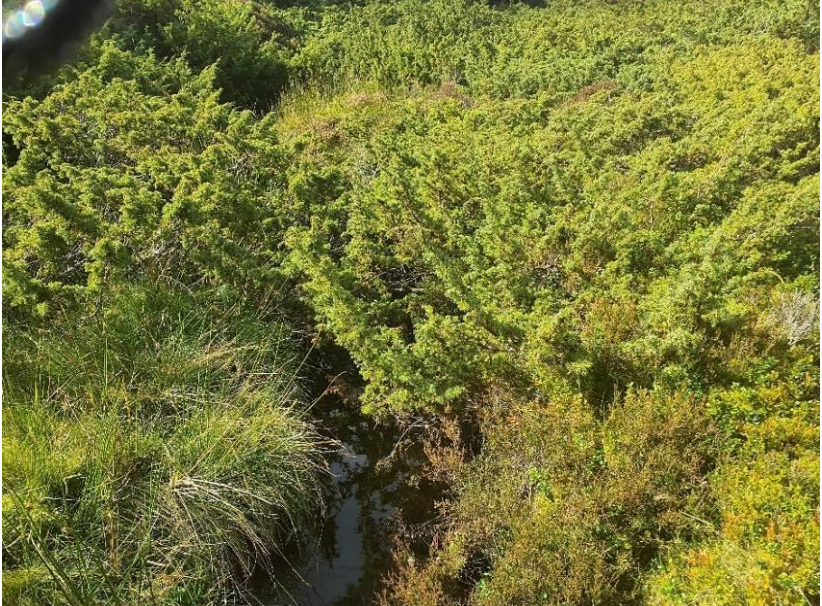
<p>TN74 Photo 73 Grid ref: NH8080020576 90cm wide channel, 20cm depth. Tunnel vegetation of extensive juniper canopy.</p>

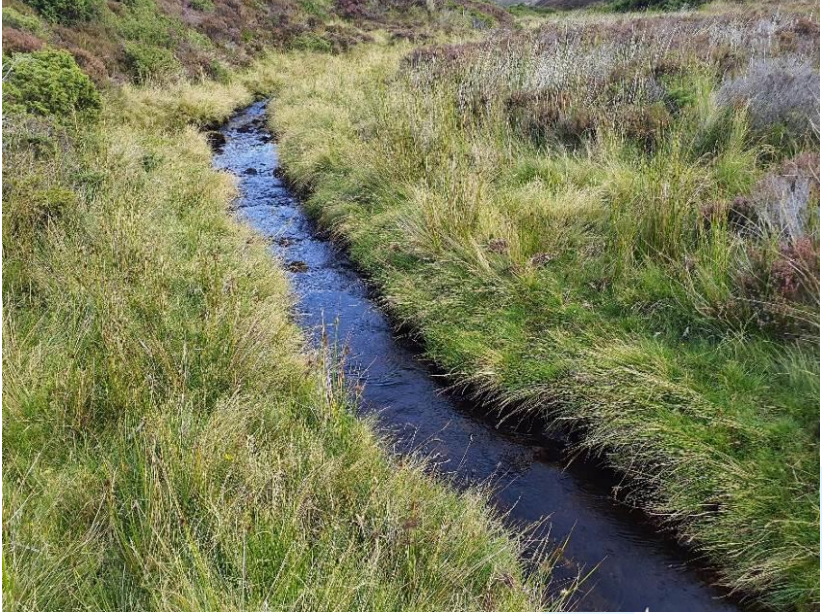
Target Note description	Photo
<p>TN78 Photo 77b Grid ref: NH8124020822 Pool 80cm depth, trout noted in pool. Some macrophage growth in glide section.</p>	 
<p>TN79 Grid ref: NH8151720697 Dry channel heavily overgrown with juniper and a steep gradient. No fish potential.</p>	 
<p>TN80 Photo 78 Grid ref: NH8160620716 1m wide between 10-15cm depth. Slow-moving water.</p>

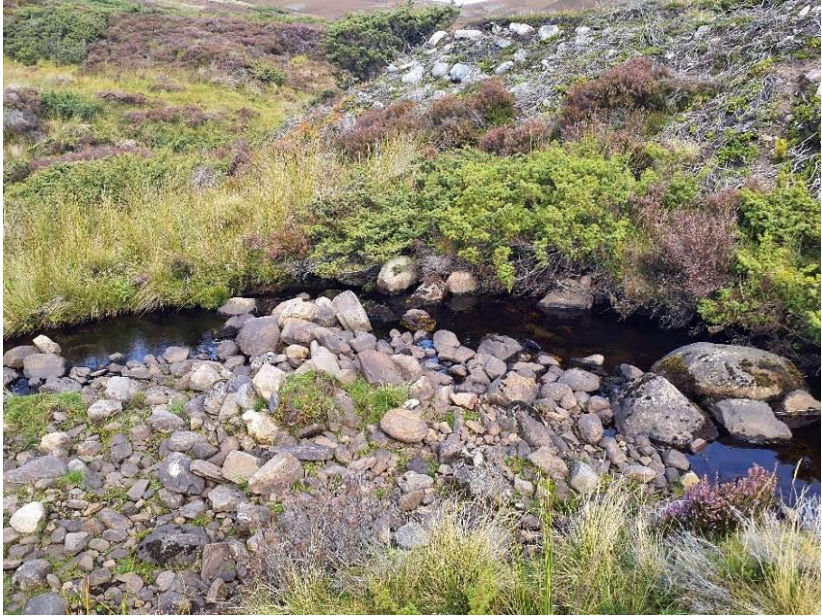
<p>TN82 Photo 79 Grid ref: NH8203320882 Point bar, 20cm depth 1.5m width. Lots of deposited boulders slow down river flow.</p>

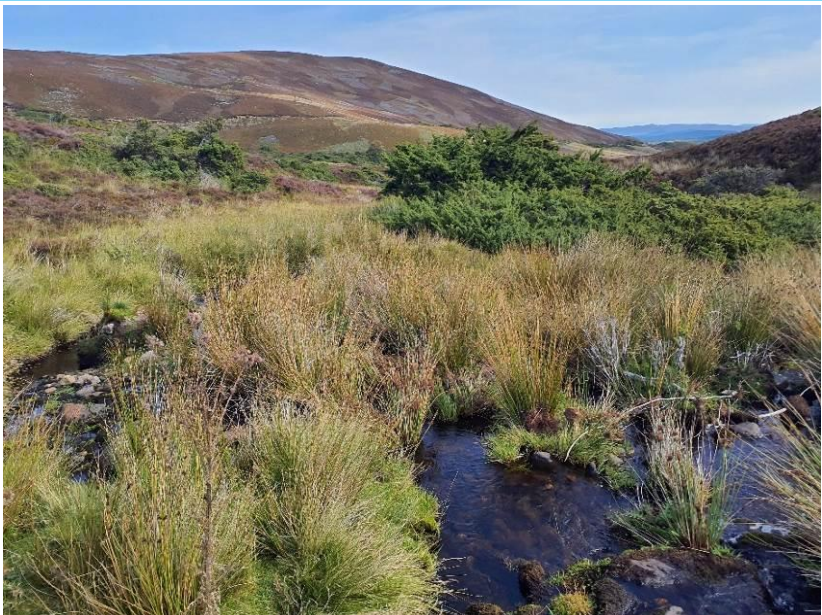
<p>TN83 Photo 80 Grid ref: NH8209620930 Channel braiding through juncus.</p>

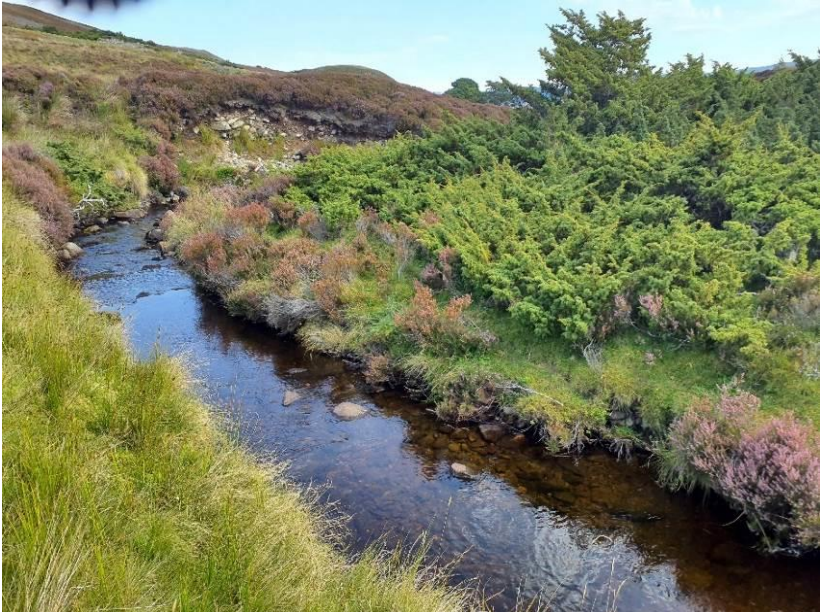
Target Note description	Photo
<p>TN87 Photo 84 Grid ref: NH8278420938 2.5m width, 25cm average depth.</p>

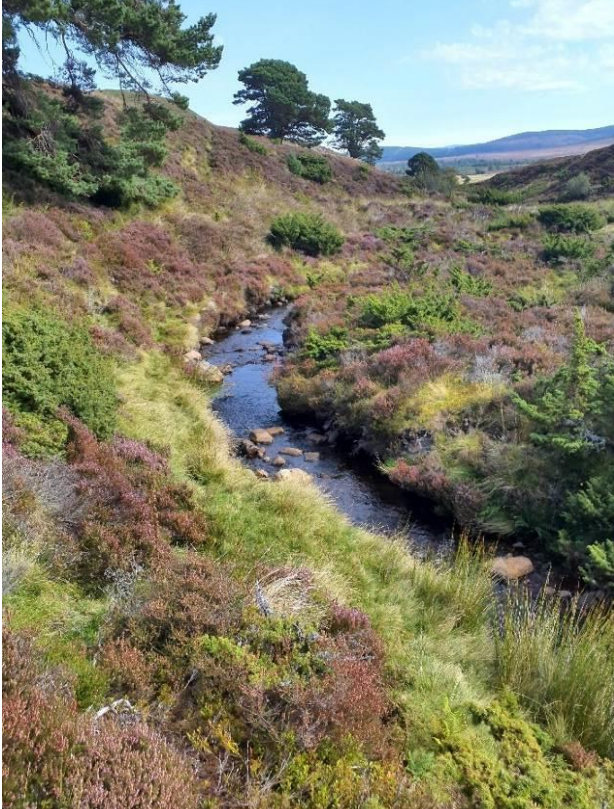
<p>TN88 Photo 85 Grid ref: NH8292320931 Width 1.5m depth 25-20cm depth. Faster flowing due to emergent boulders.</p>

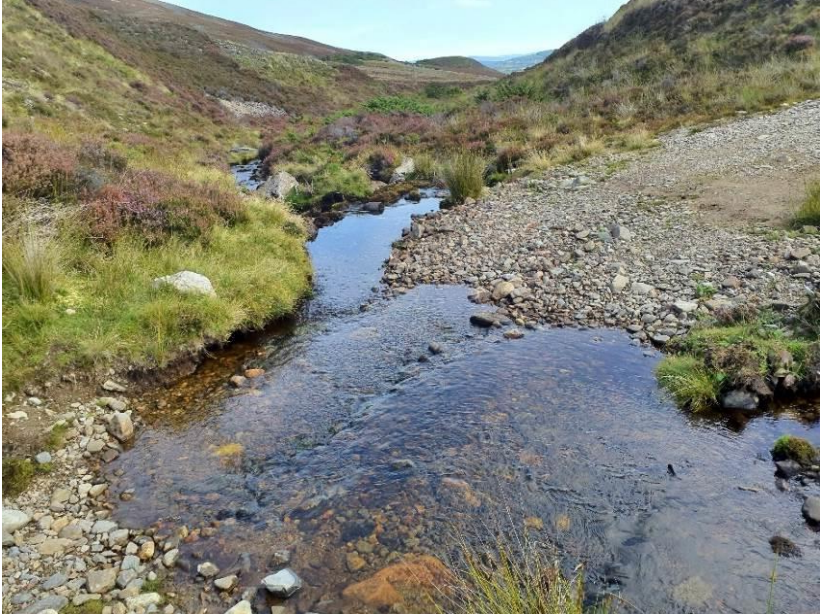
Target Note description	Photo
<p>TN89 Photo 86 Grid ref: NH8250020958 Ford over track.</p>

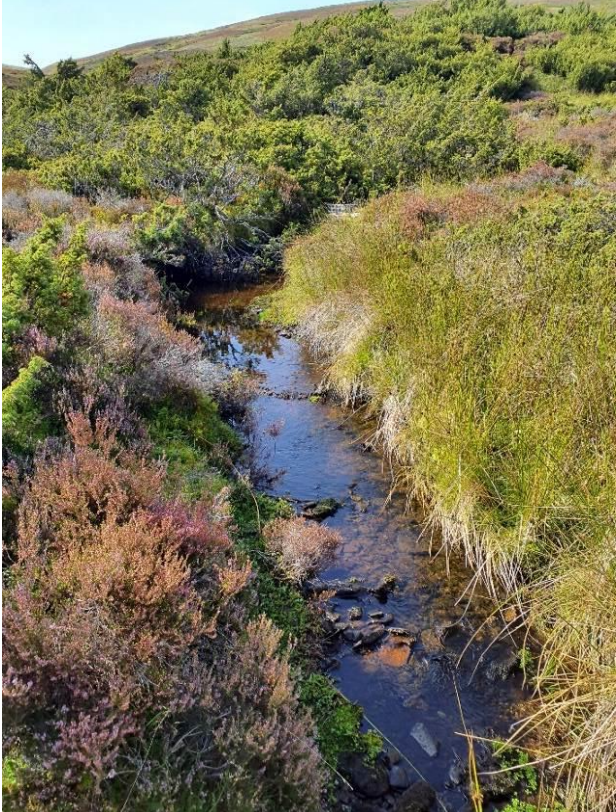
<p>TN90 Photo 87 Grid ref: NH8238521021 70cm width, 5cm deep. Extensive bank coverage of juniper.</p>

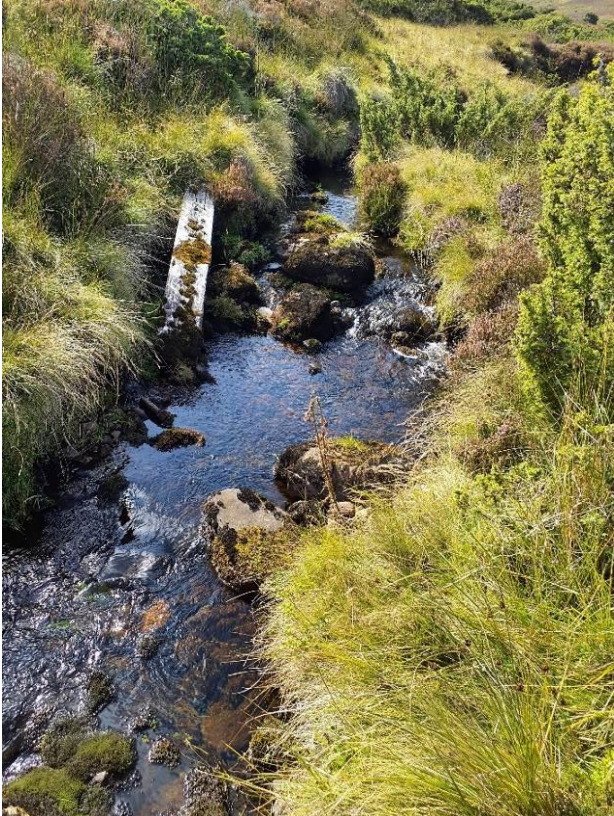
Target Note description	Photo
<p>TN91 Photo 88 Grid ref: NH8238220971 1m width, 20cm depth. Fast moving with emergent boulders.</p>

A photograph showing a narrow, shallow stream flowing through a grassy field. The water is clear and appears to be moving quickly over several large, dark rocks and boulders. The surrounding vegetation consists of tall, green grasses and some low-lying shrubs. The stream is bordered by a concrete or stone structure on the left side, possibly a culvert or a small dam.
